COMPOSITIONAL AND MICROSTRUCTURAL MODIFICATIONS IN CONCRETE ELEMENTS FROM ROMANIAN COASTLINE

MIHAELA-ANDREEA MONCEA, FLORINA-DIANA DUMITRU*, ANA-MARIA PANAIT

National Institute for Research and Development in Environmental Protection, 294 Splaiul Independentei, 6th District, 060031, Bucharest, Romania

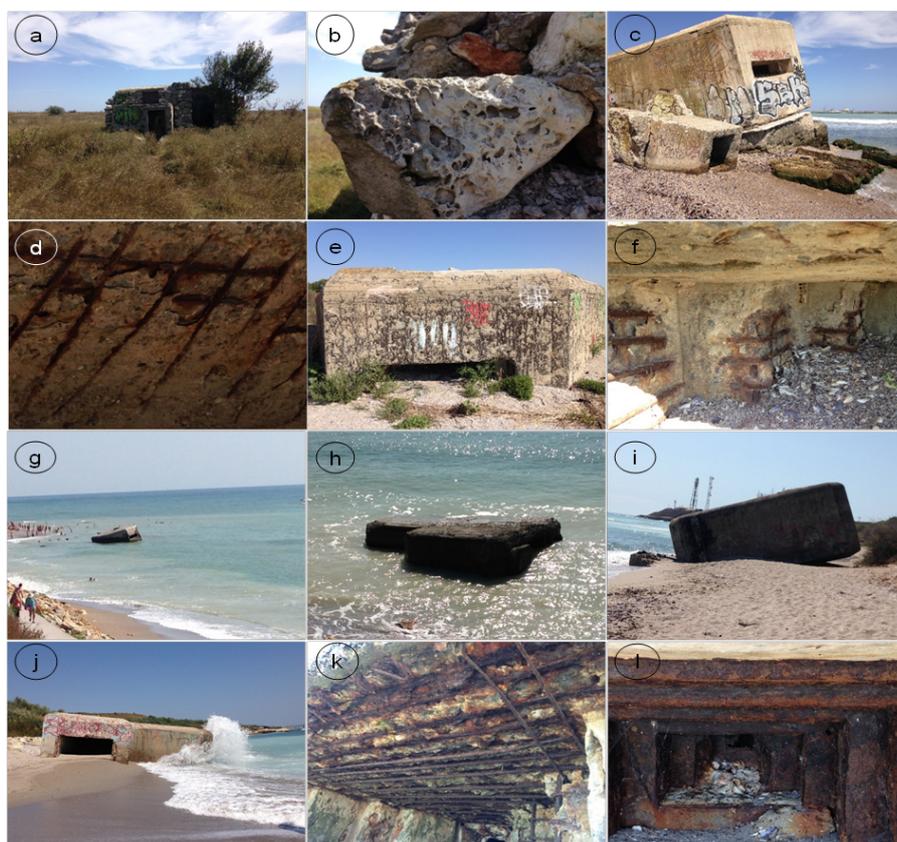
Generally, the identified and in situ examined casemates are placed on the beach, excepting one in the Vama Veche resort, placed at a relatively long distance from the beach (Fig. 1a). As a result of continuous changing of the shoreline, many casemates are currently in the sea waves (the case of casemates located on the 2 May and Tuzla beaches) or even in the sea water (case of the Costinesti casemates) (Fig. 1c, g - j). The casemates stands are severely affected due to the action of the sea waves and loss of important parts of the land due to marine erosion process. The visual examination revealed the precarious preservation state of all casemates, the concrete being strongly damaged and the reinforcement being exposed to the corrosion. The

most vulnerable parts of the casemates to the aggressiveness of marine environment are the firing holes (Fig.1d, f and k). These are areas where the metallic elements are directly exposed to marine environment (Fig. 1l), and by their corrosion the concrete layer deterioration is accelerated.

Fig. 1- Casemates situated on the Romanian seashore: a and b – casemate in Vama Veche; c and d – casemate in 2 Mai; e and f – casemate in Olimp; g and h – casemates in Costinești; i – l casemates in Tuzla beach / Cazemate amplasate pe litoralul românesc: a și b - cazemata de pe plaja Vama Veche; c și d - cazemata de pe plaja 2 Mai; e și f - cazemata de pe plaja Olimp; g și h - cazemate de la Costinești; i - l - cazemate de pe plaja Tuzla.

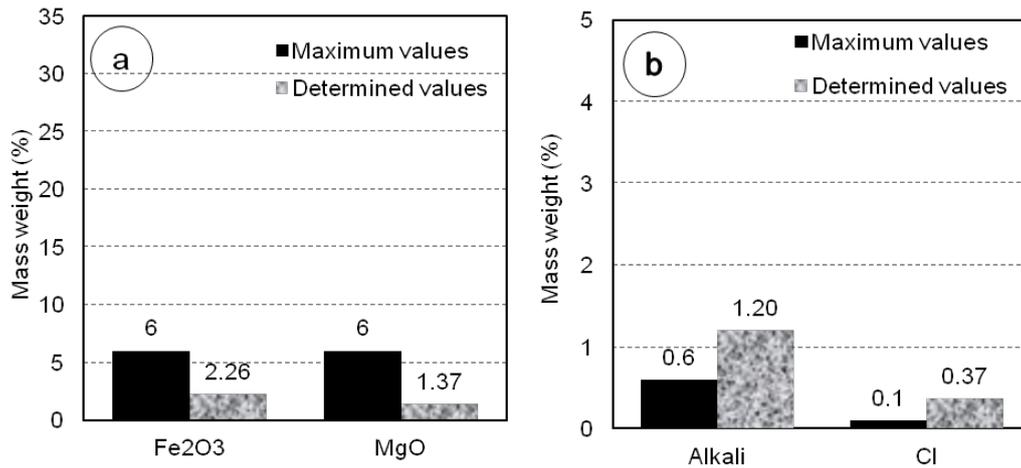
In the fine fraction of concrete sampled from Vama Veche casemate, the content of Fe₂O₃ has values below the limits imposed by the standard (Fig. 2a). This result can be explained by the fact that the corrosion of the metal reinforcement either did not begun or it is at an early stage considering its positioning at a longer distance from the beach. A similar situation can be observed for MgO, which highlights the absence of magnesium aggressiveness [3]. Due to the high content of saline ions in the atmosphere, the recorded concentrations of alkali and chlorine exceed the allowed limit values (Fig. 2b).

Fig. 2 - The content of compounds/elements involved in corrosive phenomena of the concrete specimen sampled from Vama Veche casemate: a) Fe₂O₃ and MgO oxides; b) alkali and Cl / *Conținutul de compuși/elemente implicate în fenomene corozive din proba de beton prelevată de la o cazemată din Vama Veche: a) oxizii Fe₂O₃ și MgO; b) alcalii și Cl.*

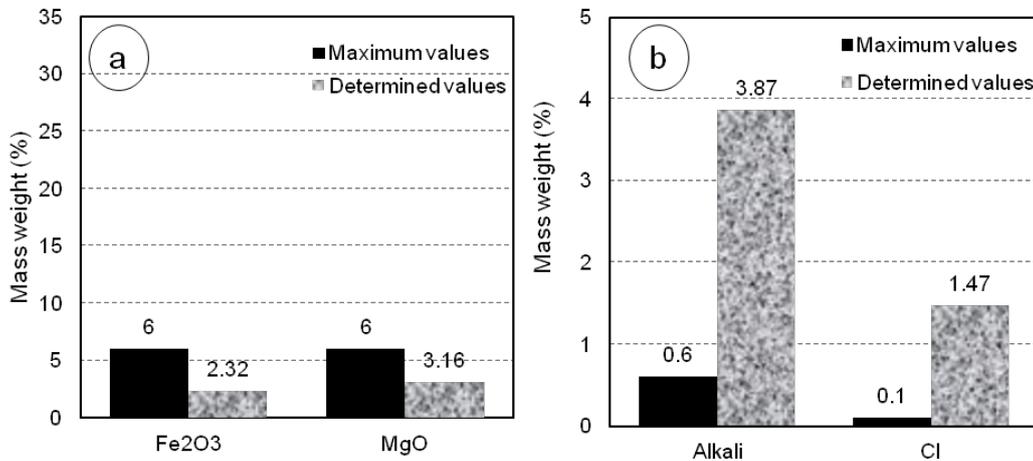
Fig. 3 - The content of compounds/elements involved in corrosive phenomena in the concrete specimen sampled from 2 Mai casemate: a) Fe₂O₃ and MgO oxides; b) alkali and Cl / *Conținutul de compuși/elemente implicate în fenomene corozive din proba prelevată de la o cazemată din 2 Mai: a) oxizii Fe₂O₃ și MgO; b) alcalii și Cl.*

A similar situation regarding the content of Fe₂O₃ and MgO oxides was observed for the fine fraction of concrete sampled from the body of 2 Mai casemate (Fig. 3a). In this case the corrosion process of steel reinforcement appeared predo-

minantly in the contact area with the sea water and does not affect the entire concrete structure. However, its position on the seashore determines a great exceeding of the limit values established for alkali and chlorine (Fig. 3b).

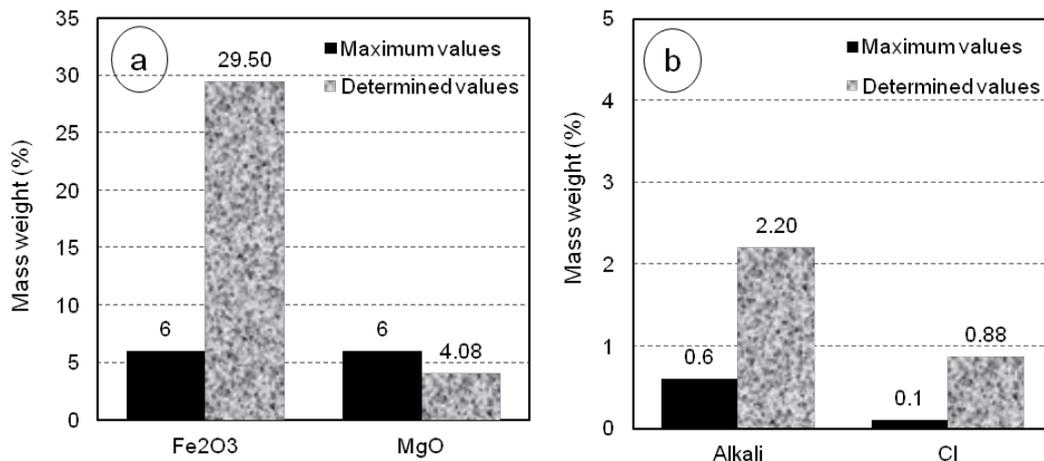
Fig. 4 - The content of compounds/elements involved in corrosive phenomena in the concrete specimen sampled from Mangalia casemate: a) Fe₂O₃ and MgO oxides; b) alkali and Cl / *Conținutul de compuși/elemente implicate în fenomene corozive din proba prelevată de la o cazemată din Mangalia: a) Fe₂O₃ și MgO; b) alcalii și Cl.*

Thus, in the fine fraction of concrete proceeded from Mangalia casemate, the concentration of Fe₂O₃ is very high – 30%, a value five times bigger than the maximum allowed limit in cement (Fig.4a). For the specimen proceeded from Tuzla casemate the Fe₂O₃ content is 23%, four times bigger than the maximum allowed limit, (Fig.5a). These results could be explained by the diffusion in the concrete matrix of supplementary Fe quantities from metallic reinforcement as a result of their excessive corrosion. In the case of MgO, the determined values did not exceed the maximum allowed limit.

For alkali (Na₂O and K₂O) and Cl content, the determined values were also above the allowed limit specified in the cement quality standard (Fig. 4b and 5b). Taking into account the position of the casemates from where concrete specimens were extracted (see Fig. 1i, j), it can be specified that

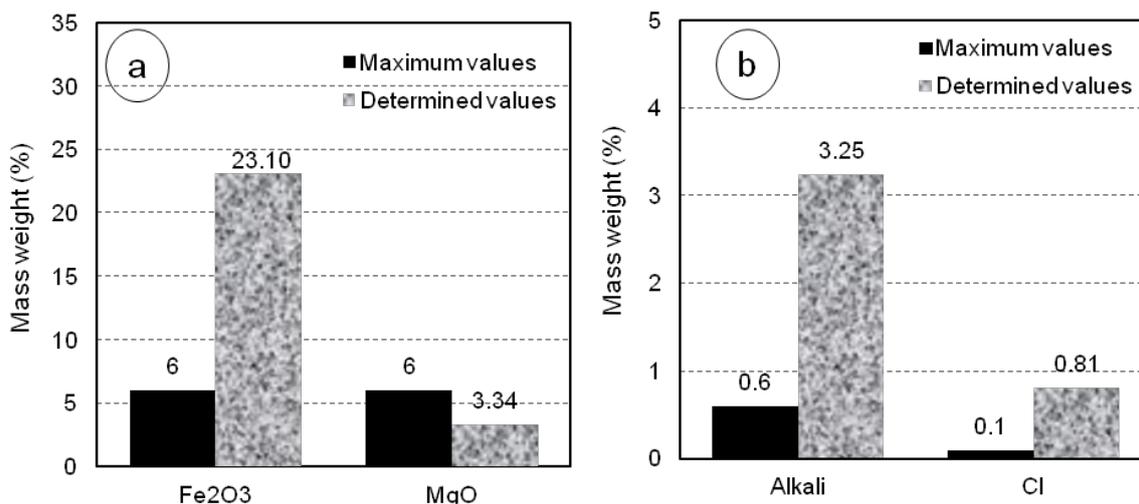
Fig.5 - The content of compounds/elements involved in corrosive phenomena in the concrete specimen sampled from Tuzla casemate: a) Fe₂O₃ and MgO oxides; b) alkali and Cl / Conținutul de compuși/elemente implicate în fenomene corozive din proba prelevată de la o cazemată din Tuzla: a) - Fe₂O₃ și MgO; b - alcalii și Cl

these higher values appear due to the saline ions intrusion, from the marine environment, through the concrete matrix. The presence of alkaline ions modifies the chemical balance of the intergranular concrete solution by the diffusion of Ca²⁺ ions to the concrete surface and the gradual solubilisation of calcium silicate hydrates which are responsible for the mechanical strength and durability of concrete.

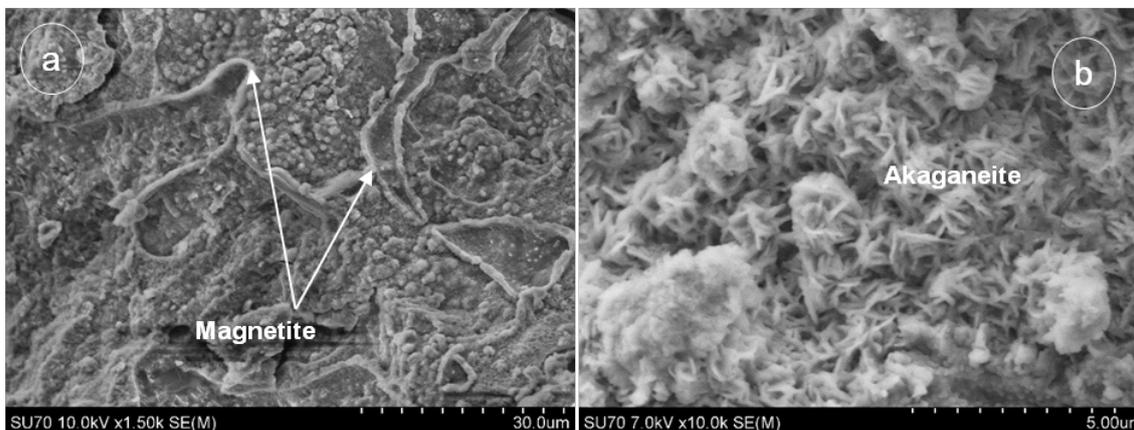
Fig.6 - SEM images performed on the concrete specimen sampled from the body of 2 Mai casemate, presented at different magnitudes: a-1,5K and b-10K / Imagini SEM realizate pe probă de beton prelevată din cazemata de la 2 Mai, prezentate la mărimi diferite: a-1,5K și b-10K.

The scanning electron microscopy (SEM) was performed on selective concrete specimens which had a damaged appearance, with visible corrosion marks. SEM analyses were coupled with EDS in order to identify the chemical elements into some observed crystalline formations. The SEM images presented in Figure 6 were obtained on a concrete specimen sampled from the body of the 2 May casemate.

Taking also into account other works [19] the crystalline formations evidenced in Figure 6a, were attributed to magnetite (Fe₂O₃). This compound forms elliptic cordons around the dendritic formations, attributed to the akaganeite

crystals (β - Fe(O,OH)) [23], highlighted in the extended image in Figure 6b. The akaganeite is a corrosion compound which is present at the concrete/metallic reinforcement interface [19, 24]. The SEM images presented in Figure 7 correspond to the microstructure of the concrete specimen sampled from the casemate in Mangalia.

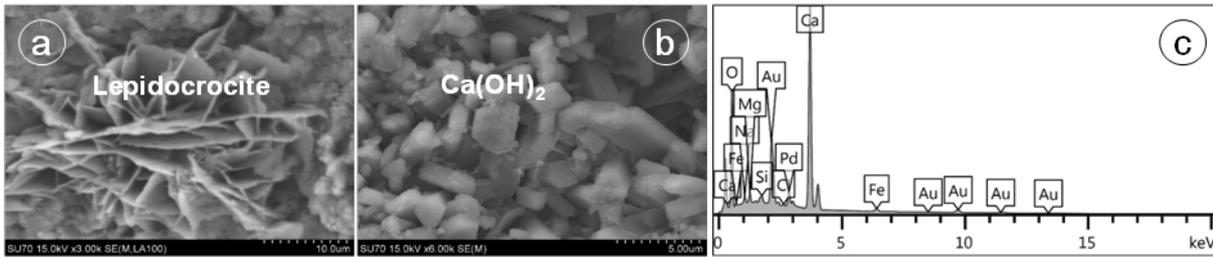
Fig.7 -SEM images performed on a concrete specimen sampled from the body of Mangalia casemate and its EDS spectrum / Imagini SEM realizate pe probă de beton prelevată din cazemata de la Mangalia și spectrul EDS al acesteia.

The analyzed concrete specimen was sampled from an area severely affected by corrosion. The microstructure is characterized by a porous and irregularly surface, in whose concavities "floral" crystalline formations were developed. By similarity with microstructures presented in other researches [19, 24, 25] these floral formations were attributed to the lepidocrocite crystals – (γ -FeOOH) (Fig.7a). The lepidocrocite is a corrosion product, being a polymorphic form of the iron hydroxide, whose development mechanism and kinetics are currently uncertain. The image presented in Figure 7b shows a region rich in calcium hydroxide, crystallized as interpenetrated hexagonal prisms, or as hexagonal plaques, often overlapped. Ca(OH)_2 was also confirmed by the EDS analysis, whose spectrum is presented in Figure 7c.

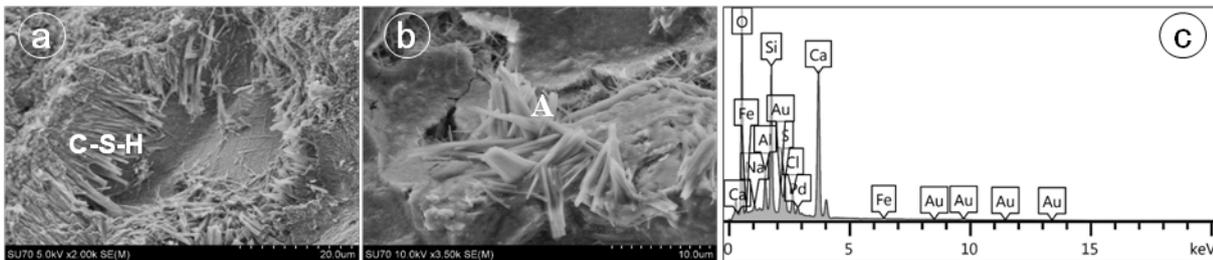
Fig.8 - SEM images performed on a concrete specimen sampled from the body of Olimp casemate presented at different magnitudes: a - 2k; b - 3,5K and its EDS spectrum (c) / Imagini SEM realizate pe probă de beton prelevată din cazemata de la Olimp la diferite mărimi: a - 2k; b - 3,5K și spectrul EDS al acesteia (c).

The SEM analyses performed on the concrete specimens collected from casemate body located on Olimp beach evidenced different microstructures compared to those presented above (Fig.8).

Thus in the SEM image presented in Figure 8a, needle shape crystals developed unidirectional or intertwined can be observed. For the A marked area (Fig. 8b), the EDS spectrum was made and it is presented in Figure 8c. The spectrum shows the presence of Ca and Si as predominant elements, what allows the assignment of these acicular formations to calcium silicates hydrates, possibly formed as crystalline compounds after a very long period of time. It is not excluded the presence of ettringite crystals as the EDS spectrum also confirms the presence of Al and S. These types of compounds have been mentioned also in other scientific papers [4, 16]. Another analyzed area, belonging to the same sample, allowed the highlighting of iron oxide, crystallized in star shape (Figs. 9a and b), developed as a result of reinforcement's corrosion and confirmed by the EDS spectrum in Figure 9c.

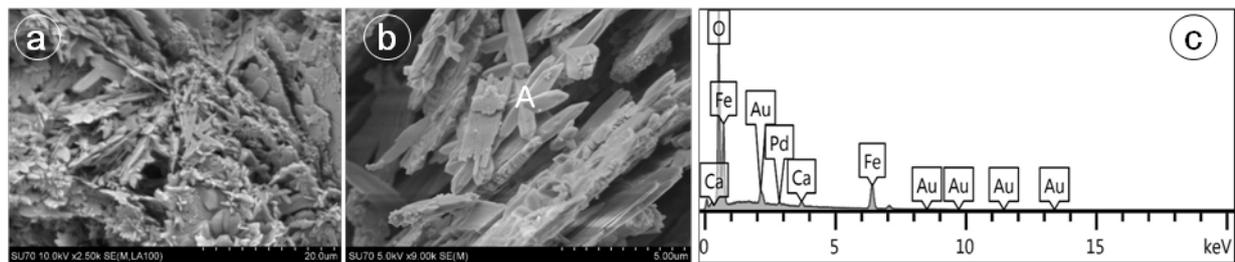
Fig.9 - SEM images performed on a concrete specimen sampled from the body of Olimp casemate (a and b) and the EDS spectrum of the A marked area (c) / Imagini SEM realizate pe probă de beton din cazemata de la Olimp (a și b) și spectrul EDS al zonei notat cu A din poziția b a figurii (c).

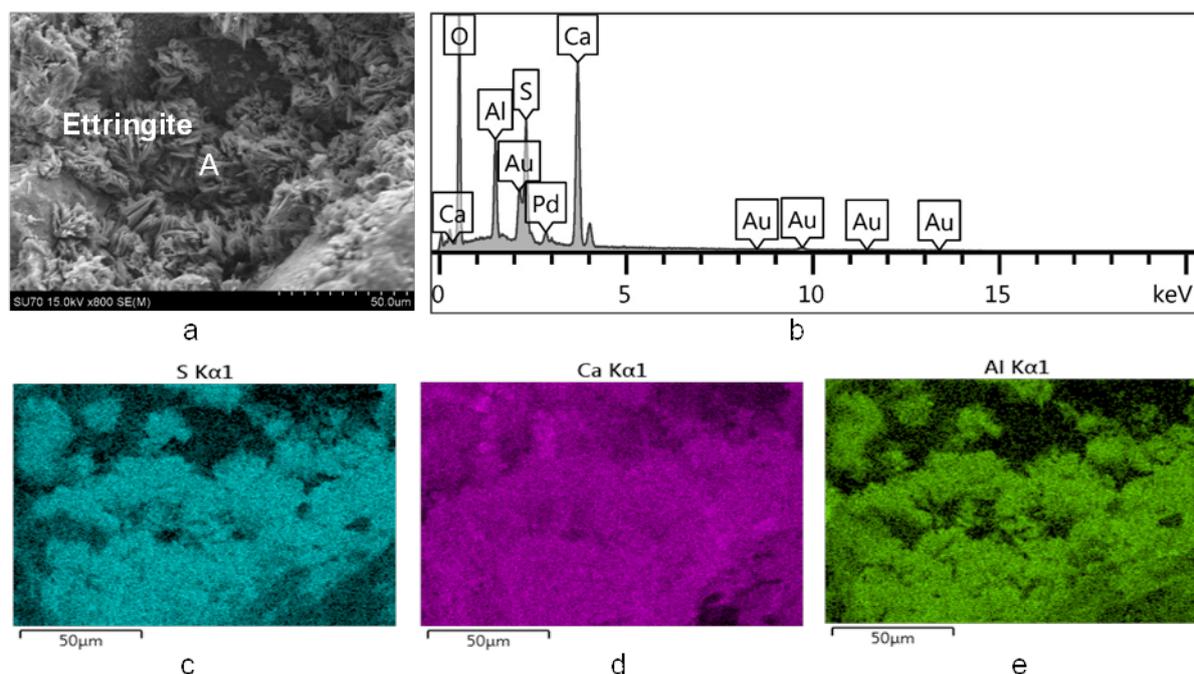
Fig.10 - SEM image (a) coupled with EDS (b) and the elemental maps (c, d and e) performed on a concrete specimen sampled from the body of Olimp casemate / Imagine SEM (a) cuplată cu analize EDS (b) și hărțile elementale (c, d și e) realizate pe o probă de beton prelevată din cazemata de la Olimp.

The microstructure presented in Figure 10a suggests another crystalline compound, namely ettringite ($C_3A \cdot 3\overline{C}S \cdot H_{32}$). This compound, crystallized in binder matrices as short needle shapes wisps, has an important role in the concrete strength, as observed in other investigations [26, 27]. Its presence was confirmed by both EDS spectra of the area marked with A (Fig. 10b) and elemental maps (c, d and e positions), which evidenced the predominance of Ca, Al and S elements.
