STUDII ASUPRA GRADULUI DE ALTERARE, CONSERVARE ȘI AL COMPATIBILITĂȚII MATERIALELOR DE CONSTRUCȚII FOLOSITE LA RENOVAREA ZIDULUI DE FORTIFICAȚII AL BISERICII REFORMATE DIN DEJ, MONUMENT ISTORIC (JUD CLUJ)

WEATHERING, CONSERVATION STATE AND COMPATIBILITY STUDIES ON THE CONSTRUCTION MATERIALS USED FOR RENOVATION OF THE HISTORICAL DEJ REFORMED CHURCH FORTIFYING WALLS

EMILIA MOSONYI^{1*}, NICOLETA COBĂRZAN²

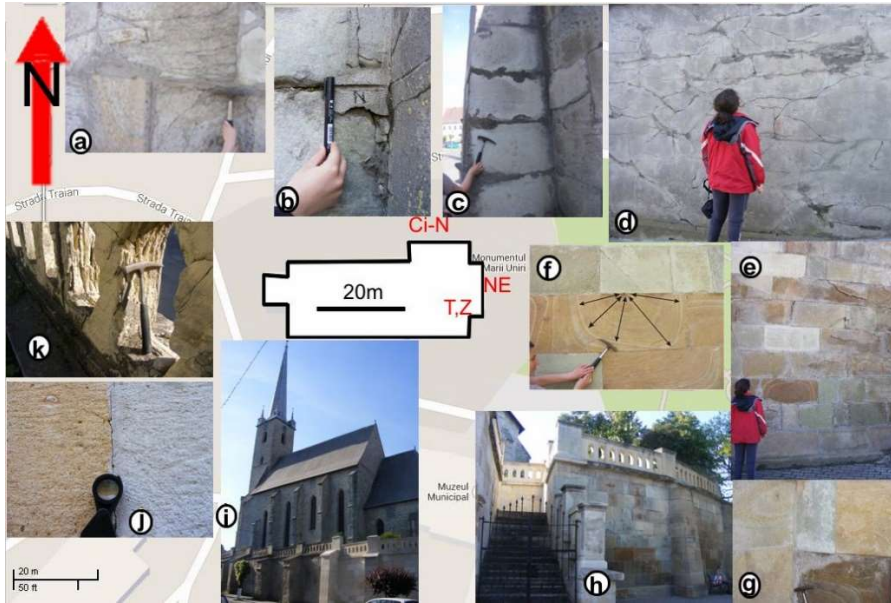
Fig. 1 - The church plan and investigated elements: north part of the wall (a- d); east (e- g) south-east (h, j), south (i) and south-west (k); the CiN, NE, T, Z sample locations. / Planul bisericii și elementele investigate: partea N a zidului (a- d); partea E (e- g); partea SE (h, j); partea S (i) și SV (k); figurează locațiile probelor CiN, NE, T, Z

The visual investigation on site revealed different states of conservation of the building walls: weathered old tuff blocks having stratification planes normal to the exposed surface (*Fig. 1a*); biological attack (fungi, lichens, moss) overexposed to high stagnant humidity zones, (*Fig. 1b*); blocks and mortars (used for repointing and rendering) on which observed different stagnant humidity (*Figs. 1c, d*); different sort types of tuff tiles and blocks, having different positions of stratification plane in exposed surfaces; diffusion controlled concentric

weathering zones (yellow, yellowish-brown) along the vertical stratification plane (arrows show the diffusion directions) (Figs. 1e- i); shrinkage fissures along bed joints between two sorts of tuff tiles (Fig. 1j); exfoliation of carved stone on the western side (Fig. 1k).

- all the tuff tiles in vertical position should be replaced with tiles cut perpendicular to the stratification in order to prevent rain water penetration;
- the use of bricks between tuff blocks should be avoided, due to geochemical incompatibility and alkali salt attack risk in walls;

- all cement based render and brick elements should be removed and replaced by unweathered grey colored tuff blocks from the same quarry (Tiocu). For fixing the tuff blocks, the same mortar receipt as previously presented should be used;

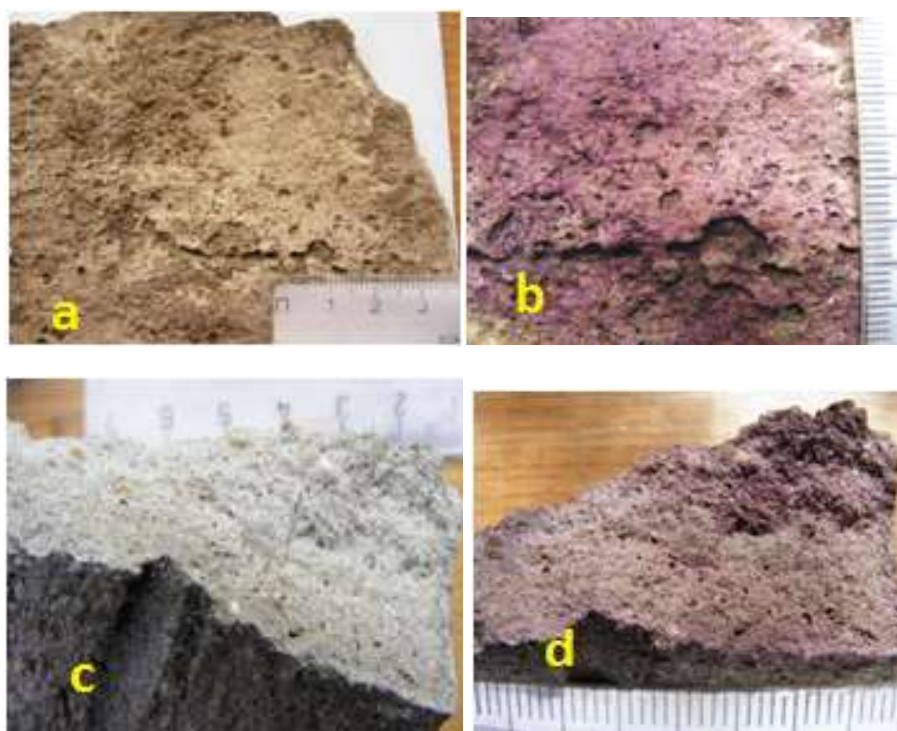
Applying a specific staining solution on inner, outer-surface and transversal section of rendered layer, the gypsum is stained purple, dolomite- very pale purple, but calcite and quartz is not colored. (Figs. 2a- d). This staining method of Friedman, 1959 [27] for dolomite discrimination was adjusted by Ingham (2013) [28] for dolomite and also gypsum identification. The result should be: "gypsum stains purple, anhydrite and calcite remain unstained, while dolomite stains very pale purple." [28] In our case, it appears that gypsum is enriched both in the outer and the inner part of the rendering layer. The causes of such gypsum enrichment are both intrinsic (the chemical composition of cement binder and extrinsic (environment pollution and moisture).

Fig. 2 - Evidence of the gypsum by the staining method, before and after coloring the CiN sample (a, b inner surface; c, d transversal section) / Evidențierea ghipsului prin colorare diferențiată a probei CiN, înainte și după colorare (a, b suprafața interioară; c, d secțiunea transversală).

Sample N is an alteration crust with salt efflorescence which was scraped along the inner side of the CiN sample. The XRD analysis of resulted dust (Fig. 7) was able to show that besides the muscovite (crystal blades used whether as an ornamental component or as admixture in render recipe for improving the deformability), there are few secondary minerals such as calcite, heulandite and gypsum (the later also evidenced on the same CiN sample by staining methods (Fig. 2).

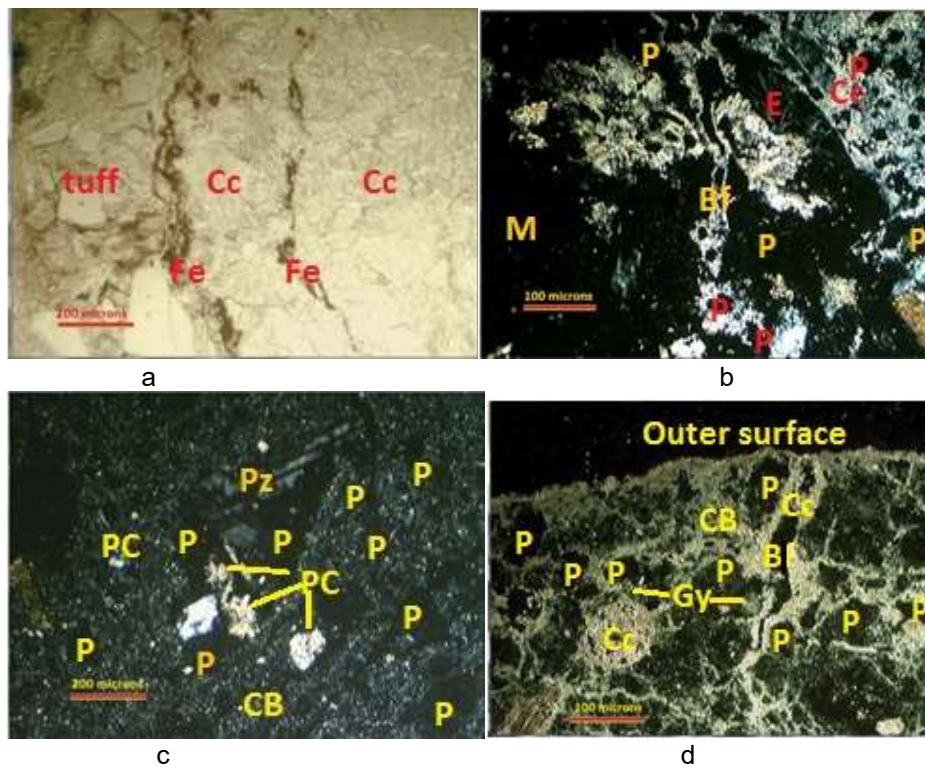
Sample G represents a weathered layer on replaced tuff block, which consist of an external mainly hard calcitic cover with iron hydroxide films (Fig. 3a). Under it, there is a palagonitic volcanic glass matrix (60 % of the rock's volume) with shards and phenocrysts of quartz, chloritised biotite, amphibole and carbonated zeolitised plagioclase. The weathered, exposed side of tuff contains many elongated voids running normal and subparallel with its surface. The voids are outlined by calcite grains and a thin film of $\text{Fe}(\text{OH})_3$.

The microscopically studied **NE sample** is a little piece of exfoliated mortar or grout which fell due to moisture and weathering. The mortar is cement-dominated and appears as a cryptocrystalline carbonated mass with hydrated and partially hydrated relic cement grains (belite, ferrite). In the external part, it is intensively leached, having microporous structure with secondary carbonate deposits containing gypsum filled voids.

The mortar's fine aggregates, mainly feldspars, were partially or totally pseudomorphosed (replaced) by gypsum crystals and "popcorn calcite" (Sibbick and Crammond, 2003 [34]) deposition.

In *Figure 3b* of **NE mortar** there is a porous secondary CO₃ crust (upper right corner) on the cement based mortar surface. In the mortar can also observe bleeding fissures and leaching effects. In an elongate void there appears to be ettringite filling (needles with dark grey birefringence). In the same NE mortar sample from *Figure 3c* can observe plagioclase clast and "popcorn calcite" deposition, the later due to cement + unhydrated lime based mortar decay. The *Figure 3d* of NE sample illustrates weathered mortar surface with high porosity, shrinkage fissures, bleeding fissures (channels) network with carbonate, promoted by

AAR. The voids (circular pores, V- shaped extensional fissures) linked between by bleeding fissures running parallel with the surface and are lined by gypsum and secondary carbonate. The map fissures, meeting in triple points (dry shrinkage, French, 1991 [35]) are filled also by secondary minerals (e.g. calcite, gypsum or secondary ettringite).

Fig. 3 - Microphotos of G, NE sample thin sections: a) G sample: boundary between tuff (left side) and weathering iron hydroxide + carbonate crust (right side). Scale bar 200 micrometers (N/), (Cc = calcite, Fe = iron hydroxides). b) NE sample of mortar: porous secondary carbonate crust (upper right corner) on the cement based mortar surface. There are bleeding fissures and leaching effects. In an elongate void there appears to be ettringite filling. Scale bar 100 micrometers (N+) (Cc= calcite crust, P= pores, Bf= bleeding channel, fissure, E= ettringite needles). c) NE sample of mortar: plagioclase clast and "popcorn calcite" deposition. Scale bar 200 micrometers (N+), (Pz= weathered plagioclase clast, P= pore, PC= popcorn calcite, CB = carbonated cement binder). d) NE sample of mortar: weathered cement + lime based mortar surface: high porosity, shrinkage fissures, V- shaped extensional fissures, bleeding fissures network with carbonate, promoted by AAR. The voids lined by gypsum and secondary carbonate. Scale bar 100 micrometers (N+). (P=pores, CB= porous carbonated cement binder). / *Microfotografii de secțiuni subțiri pe probele G, NE: a) Proba G: limita dintre tuful vulcanic (partea stângă) și crusta de alterare cu hidroxizi de fier + carbonat (partea dreaptă). Bara de scară 200 micrometri (N/). (Cc = calcit, Fe= hidroxizi de fier). b) Proba mortar NE: crustă de carbonat secundar, microporoasă (colțul drept sus) pe suprafața mortarului pe bază de ciment. Se observă fisuri și efecte de levigare. Într-un por alungit pare să fie umplutură de ettringit. Scara de bară 100 micrometri (N+). (Cc= crustă calcit, P= micropori, Bf= canal de levigare, E= ace de ettringit). c) Proba mortar NE: Clast de plagioclaz din mortar și depuneri de calcit tip popcorn. Scara de bară 200 micrometri (N+). (Pz= clast de plagioclaz alterat, P= por, PC= calcit tip popcorn, CB= liant de ciment carbonatat). d) Proba mortar NE: suprafață alterată de mortar pe bază de ciment + var: porozitate ridicată, fisuri contracționale de uscure, fisuri extensionale sub formă de "V", rețea fisuri de levigare cu umplutură carbonatică, inițiată de AAR. Golurile sunt tapetate cu ghips și carbonat secundar. Bara de scară 100 micrometri. (N+). (P= por, CB= liant de ciment carbonatat, poros).*

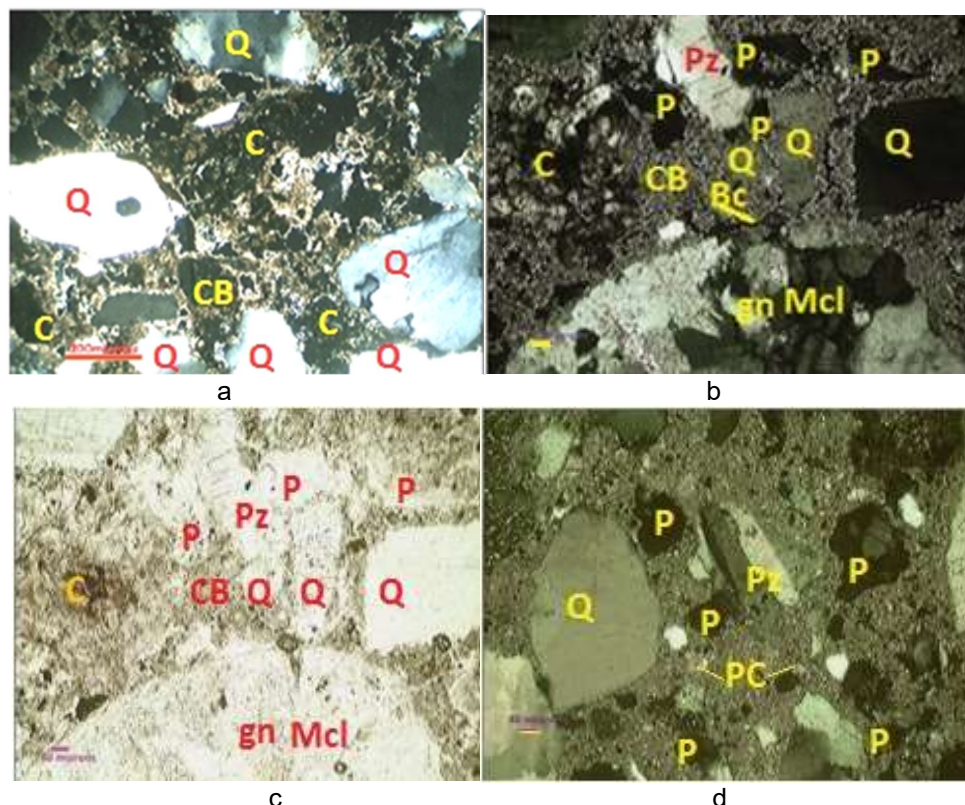
The **CiN sample** is a Portland cement based old rendering collected from the N part of the fortifying wall. The petrographic observations (*Fig. 4a*) showed that in mortar, the cement: aggregate ratio is of about 1:2. The carbonated cement binder is highly porous and partially leached in elements. The mortar matrix is mainly amorphous up to cryptocrystalline in the inner part of the render. The

Fig. 4 - Microphotos of old (CiN) and newer (T, Z) mortar samples: a) CiN sample: relic Portland cement grain (alite C_3A , belite C_2S , opaque ferrite) with carbonated corona in the mortar's binder. Scale bar 200 micrometers. (N//) (C= insufficiently hydrated relic cement grain, CB= hydrated cement binder, Q = quartz grain). b) T sample: poorly sorted (graded) sand in mortar. Microcline gneiss lithoclasts and quartz grain having a good reaction (adherent) corona with the cement binder. On the left side is an insufficiently hydrated relic cement grain containing C_3S , C_2S with twin lamellae, isotropic C_3A and opaque ferrite. Scale bar 40 micrometers. (N+) (gn Mcl = lithoclast of microcline gneiss, Pz= plagioclase, Q= quartz, C= relic cement grain, Bc = bleeding channel linking pores, CB = carbonated cement binder). c) Same as b), but N//. Scale bar 40 micrometers. d) Z sample: zeolitized twinned plagioclase (Pz) and quartz clasts are in a carbonated cement + hydraulic lime (evidenced by "popcorn calcite") binder matrix. The pores are sometimes linked between by bleeding channels (bottom right corner). Scale bar 40 micrometers. (N+) / Microfotografii pe probe de mortar vechi (CiN) și mai nou (T, Z): a) Proba CiN: granule de ciment relic (C_3A izometric, C_2S cu lamele de maclă, C_3S izometric având birefrință gri), având o coroană carbonică subțire, Bara de scară= 200 micrometri. (N+). (C= granule de ciment relic, CB= liant de ciment hidratat, Q= granule de cuarț). b) Proba T: nisip slab sortat (sortare gradată) în mortar: litoclast de gneis microclinic și granule de cuarț, având coroană de reacție bine dezvoltată (aderentă) la contactul cu liantul de ciment. În partea stângă a imaginii este un granule de ciment insuficient hidratat, conținând C_3S , C_2S cu lamele de maclă, C_3A izotrop și ferrit opac. Bara de scară 40 micrometri. (N+). (gn Mcl= litoclast de gneis microclinic, Pz= plagioclast, Q= cuarț, C= granule de ciment relic, Bc= fisuri de levigare interconectând micropori, CB= liant de ciment carbonatat). c) Similar cu b) dar N//. Bara de scară 40 micrometri. d) Proba Z: Claste de cuarț și plagioclast (Pz) maclat, dispuși în matricea liantului compus din ciment carbonatat + var (ultimul subliniat de "calcit tip popcorn"). Porii uneori sunt interconectați prin fisuri de levigare (colțul dreapta jos). Bara de scară 40 micrometri. (N+).

voids are frequently filled with secondary minerals ($Fe(OH)_3$, sulphates and carbonates). The aggregates are angular, sub-angular and present fissured and sub-rounded mainly feldspar, quartz, garnet grains, and lithoclasts of andesite, quartzite and gneiss. Along grain boundaries there are many pores, linked between by leaching fissures and an ASR induced microscopic pore network. Can also observe many relic Portland cement grains in the mortar's binder probably due to using incorrect water: cement ratio. The insufficiently hydrated relic cement grains contain: opaque ferrite C_4AF needles, short prismatic alite C_3S , light colored lamellae of belite C_2S . Relic cement grains were covered by a thin carbonated corona.

Samples T and Z (Figs 4b-d), both represent newer restoration mortars with a binder: aggregate ratio around 1:3. It is based on: Portland cement, hydraulic lime and fine aggregates of

natural sand. The sand component contains mixed rounded (mainly 1-2mm size) and sub-angular grain forms (pyroxene, amphibole, garnet, quartz, perthitic feldspar, zeolitized plagioclase, opaque minerals, biotite, calcite and lithoclasts of andesite, microcline- gneiss and quartzite) with graded granulometry, i.e. poorly sorted sand which ensures a very good adherence between mortar components and low permeability, based on Ingham, 2013 [28] observations. In the fine grained carbonated binder was also observed: partially hydrated cement grains (belite, alite and intergranular phases such as ferrite and aluminates) of 100 micrometers, entrapped irregular pores of 30-40 micrometers, circular entrained voids of around 50 micrometers, probably owing to using an additive (providing more space for freezing water). The render have porosity of 10-20 % of thin section area, but porosity may also due to inadequate

compaction. The pores appear to be linked by bleeding channels. The mortar binder consists of carbonated cement and hydraulic lime, the latter evidenced by "popcorn calcite". On the left side of Fig 5c there is an insufficiently hydrated relic cement grain containing: C₃S, C₂S with twin lamellae, isotropic C₃A and opaque C₄AF. The frequency of relic cement grains are also due to improper binder recipe, i.e. incorrect water: cement ratio and the water insufficiency could have been intensified by zeolites hydration.

- for repointing of bed layer blocks, one should use mortar having mixture compositions compatible with tuff and existing mortar (e.g. tras or hydraulic lime as binder and natural uncrushed riversand to avoid ASR) and possibly some admixtures either for biologic disinfect or freeze- thaw effect reduction or to improve mortar workability;

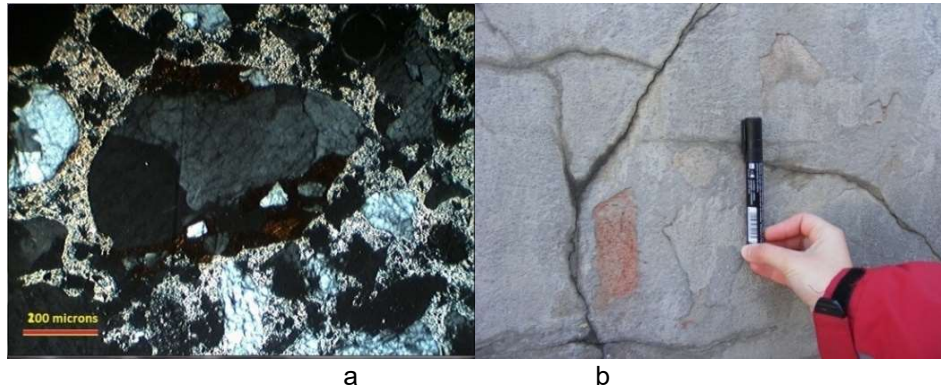
Fig. 5 - a) Microphoto of old CiN mortar (dark rims of ASR gels, in the left part, N+). The scale bar is 200 micrometers. b) Macroscopic map fissures on the same wall as sample CiN . The red colored brick appears under weathered render. Here may also observe that the brick was covered, at least twice, by Portland cement based render./ a) Microfotografia mortarului vechi CiN (conture izotrope de geluri tip ASR, partea stângă). Bara scării este de 200 micrometri. Imagine N+. b) Fisurare tip hartă la scară macroscopică, pe același perete ca proba CiN. O cărămidă roșie apare de sub tencuiala alterată. Se pot de asemenea observa și două straturi de tencuială pe bază de ciment Portland acoperind cărămida.

An ASR (a type of alkali-aggregate-reaction –AAR- Stanton, 1940 [36]) deleterious phenomenon can be observed in the sample CiN microphoto

(Fig. 5a). Highly fissured quartz grain experienced ASR. Resulting silica gels are cryptocrystalline (dot-like spots with white birefringence in Fig. 5a), were deposited along its fissures and around grain radiating micrometric fissures in the carbonated matrix. In Figure 5b is outlined the intrinsic ASR combined with frost attack and leaching and the map-fissures resulted on macroscopic scale. The alkali sources are cement minerals and bricks' metakaolinite. In the picture may also observe that the brick was covered by two successive thin layers of Portland cement based render, of which humidity could reactivate the dissolution- deposition cycles.

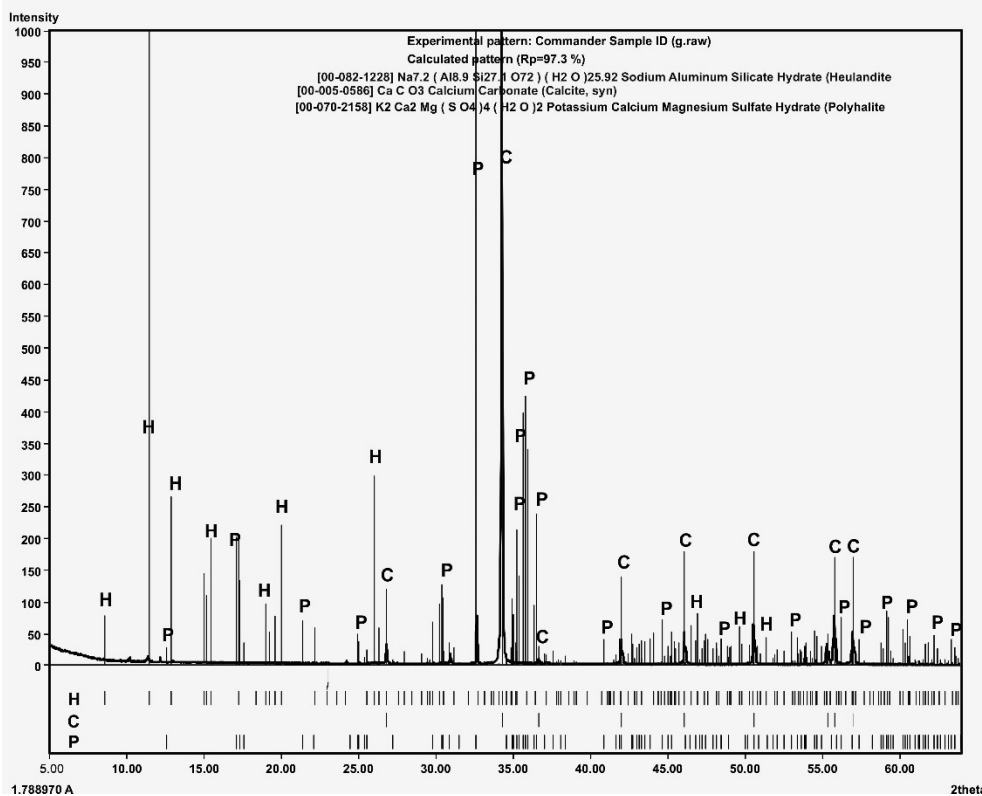
Fig. 6 -The XRD pattern of sample G (surface weathering crust of replaced tuff block): calcite (C) 96% and <4% polyhalite (P) and heulandite (H)./ Difractograma probei G (crustă de alterare): calcit (C) 96%, iar polihalit (P) și heulandite (H) sub 4%.

The XRD pattern of sample G (Fig. 6) demonstrated the presence of calcite (96 %) in the weathering crust of replaced tuff blocks and a potentially high probability of polyhalite beside secondary heulandite. Other secondary minerals could not be identified by this method due to very low quantity and the metastable or instable feature of such secondary minerals, depending on the sample's moisture.

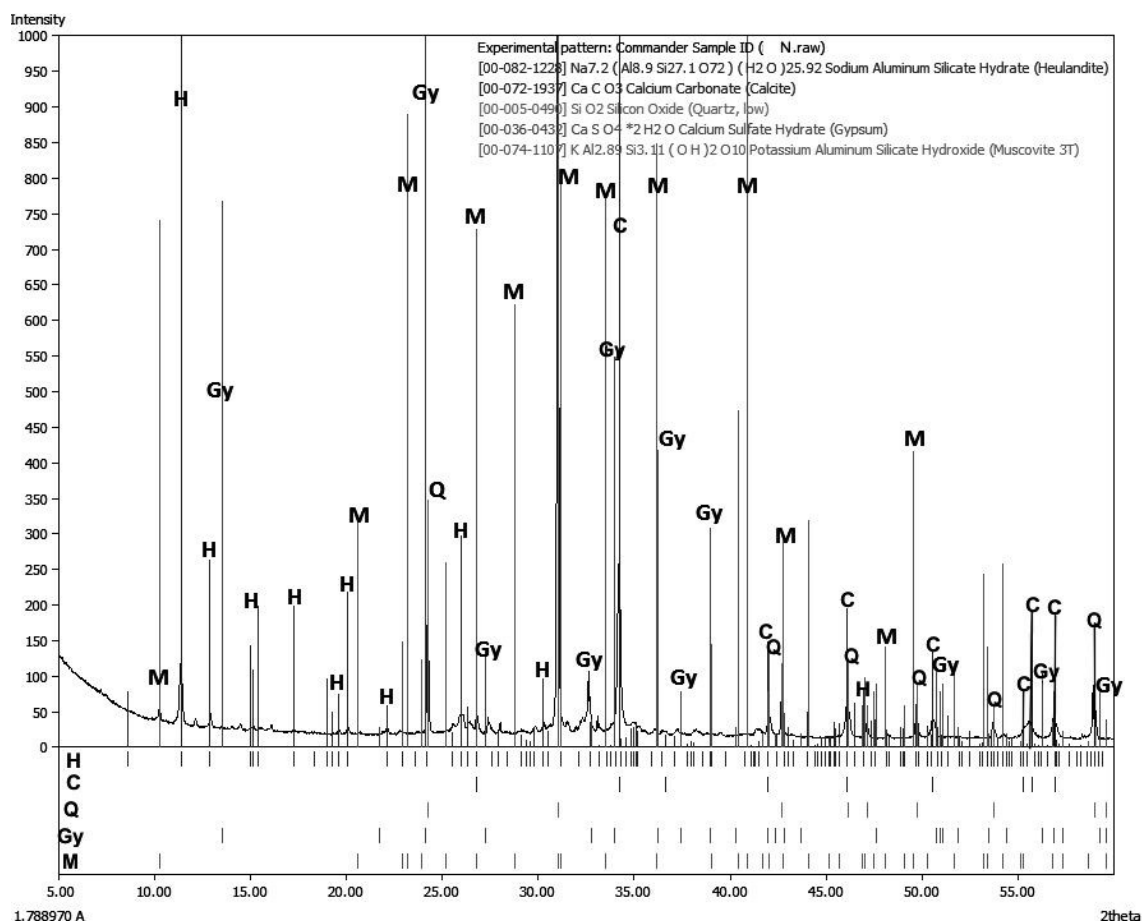
Fig. 7 - The XRD pattern of sample N (render's weathering crust from the northern wall). Composition: heulandite (H) 2.9%, calcite (C) 10.6%, quartz (Q) 9.6%, gypsum (Gy) 20.3%, muscovite (M) 56.6%. / *Difragrama probei N (crustă de alterare pe tenucială din zidul N). Compoziția: heulandit (H) 2,9%, calcit (C) 10,6%, cuarț (Q) 9,6%, ghips(Gy) 20,3%, muscovit (M) 56,6%.*
