PRE-RESTORATION MATERIALS RESEARCH IN HISTORICAL ANKARA CASTLE

AHMET GÖKDEMİR^{1*}, TALAT YATKIN²

¹Gazi University, Technology Faculty, Civil Engineering Department, Ankara-Turkey

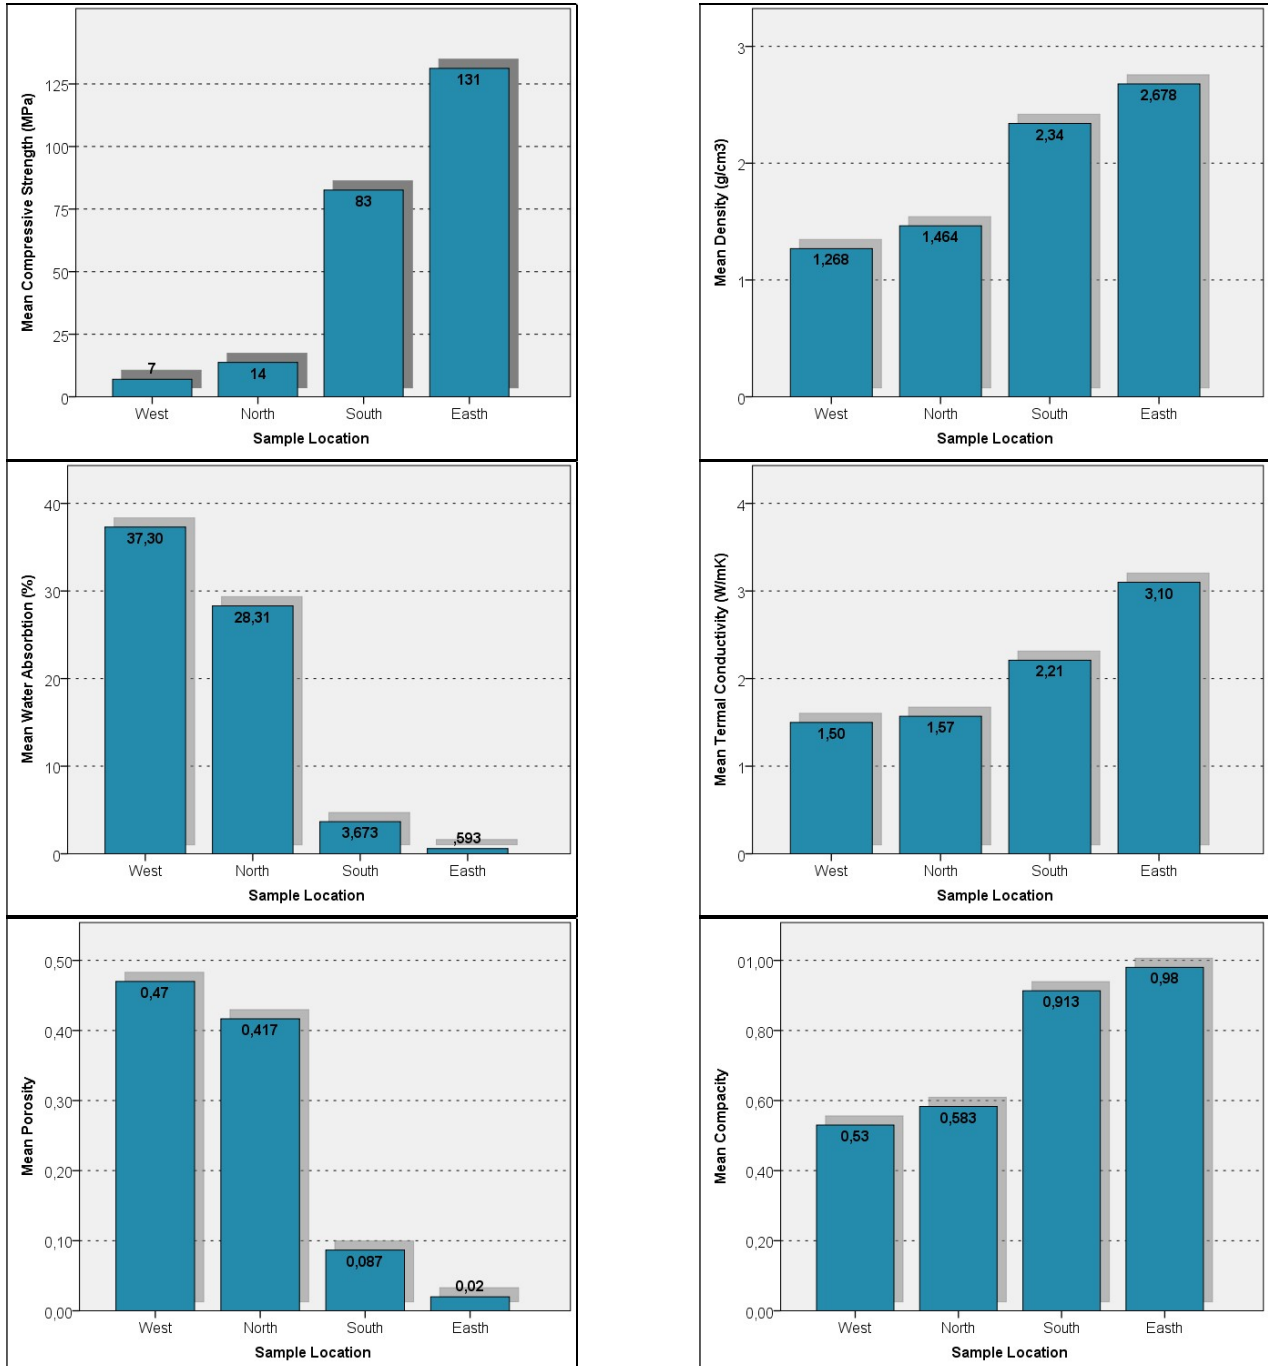
Fig. 2 - Average values of specimens properties

The bar graphs on average values of compressive strength, density, water absorption, thermal conductivity, porosity and compacity tests performed on samples taken from east, west, north and south facades of historical Ankara Castle are shown in Figure 2.

When the experiment results are examined, it was observed that samples taken from the east facade had the highest values in terms of compressive strength, while samples taken from the west facade had the lowest values. As the density, it was understood that samples taken from the east facade had the highest values, while samples taken from the west facade had the lowest values. Regarding the water absorption test, it was determined that the average water absorption values of the samples taken from the east facade were the lowest, while the average water absorption values of the samples taken from the west facade were the highest. When the porosity test is examined, it is seen that the samples taken from the east facade have the lowest porosity and the samples taken from the west facade have the highest porosity. Regarding the compactness, it was understood that samples taken from the east facade had the highest average compactness, while those taken from the west facade had the lowest average compactness. When examined in terms of thermal conductivity, it was determined that the samples taken from the east facade had the highest average value and the samples taken from the west facade had the lowest average value.

Especially granite used in the construction of the structures on the eastern facade has significantly higher values than the materials used in the construction of buildings on other facades.

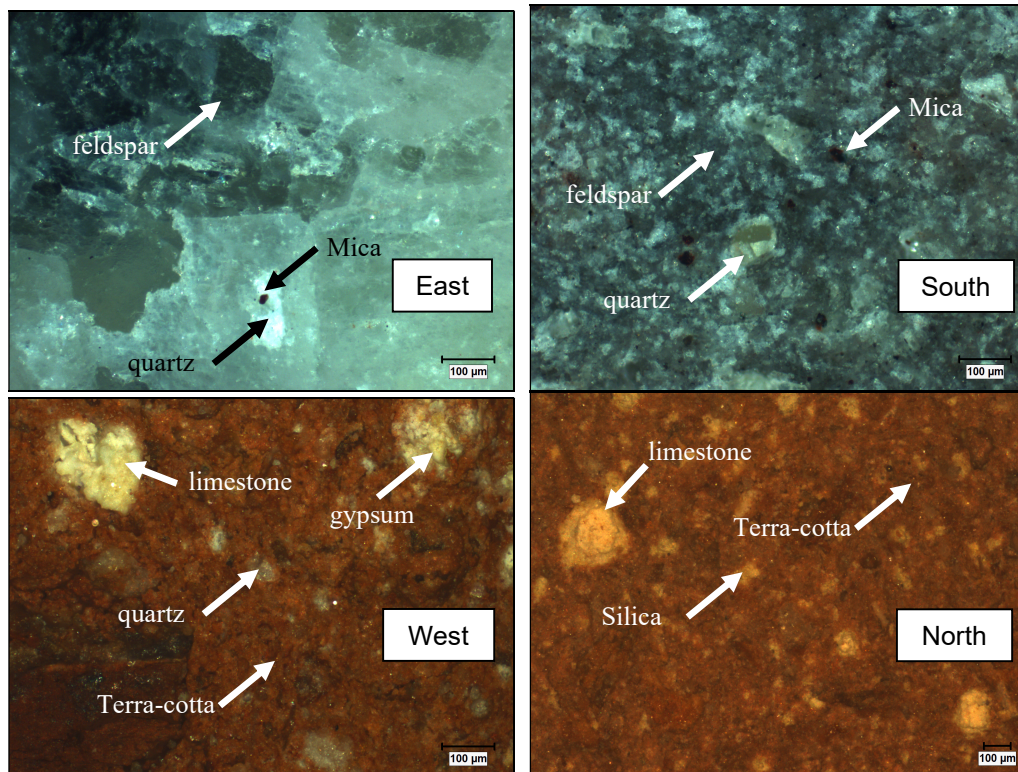
Fig. 3 - Optical microscope images of samples.

Samples taken from Ankara Castle were smoothed and micro structures were examined under optical microscope. The optical images of the samples taken from different facades are seen in Figure 3.

When the optical microscope images are examined, it is seen that the stones used in the southern facade of Ankara Castle are consisted of high-density andesite containing mica and feldspar in the volcanic rock group. This stone type which is light gray, fine grained, less porous and has high mechanical strength, mineral hardness is 6-7 (Mohs) and in natural conditions there can not have a high risk of deterioration. When the optical microscope images are examined; it is determined that the stones used on the eastern facade are high-purity andesite containing mica and feldspar from the volcanic rock group. It is observed that the western and northern facades of the castle walls are composed of baked clay products which contain silica, limestone and gypsum with a lower density compared to the materials used in other facades. This observation is supported by SEM, EDS and FT-IR analyzes.

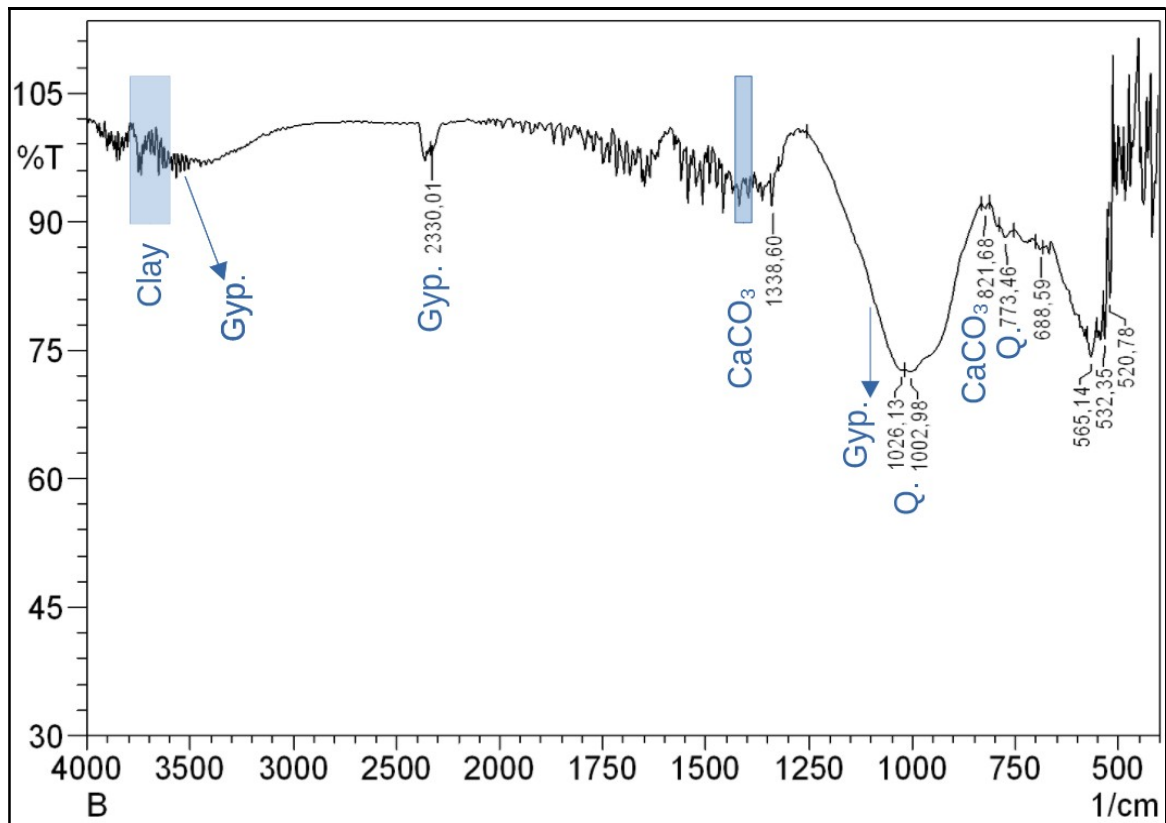
a- West sample

When the FT-IR vibrations of the materials obtained from the facades were examined, differences were observed in the vibrations of silicon oxygen (Si-O) interactions. Si-O asymmetric stress vibrations were observed in the western sample at 1026 cm^{-1} while in the eastern sample this vibration was observed at 987 cm^{-1} . This vibration was observed at 993 cm^{-1} in the southern

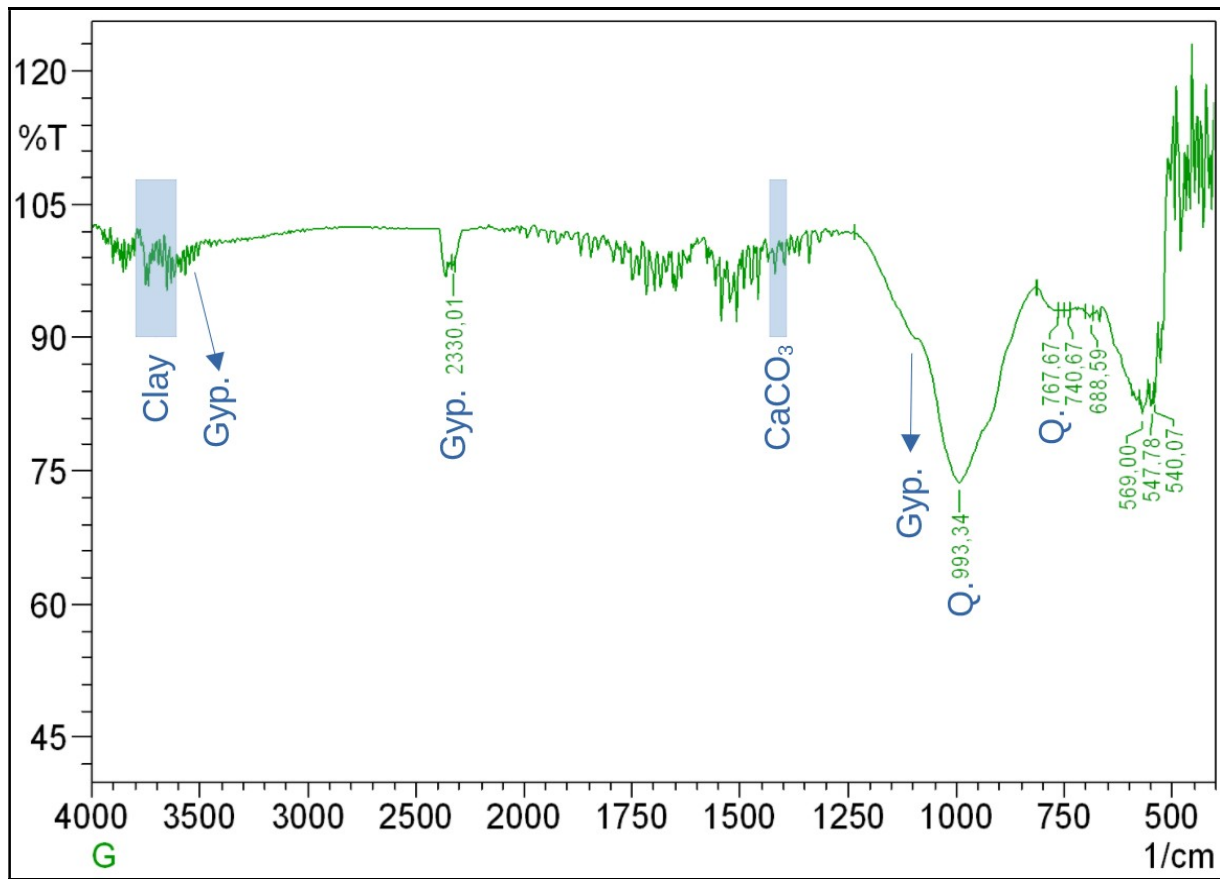
c- South sample

sample and 981 cm^{-1} in the northern sample. This absorption band range corresponds to quartz minerals. Si-O asymmetric stress vibrations and Si-O symmetrical stress vibrations were observed in the region of $800\text{ cm}^{-1} - 750\text{ cm}^{-1}$ and Si-O bending vibrations were observed in $700\text{ cm}^{-1} - 500\text{ cm}^{-1}$ region. When these vibrations were examined, differences were observed both in Si-O

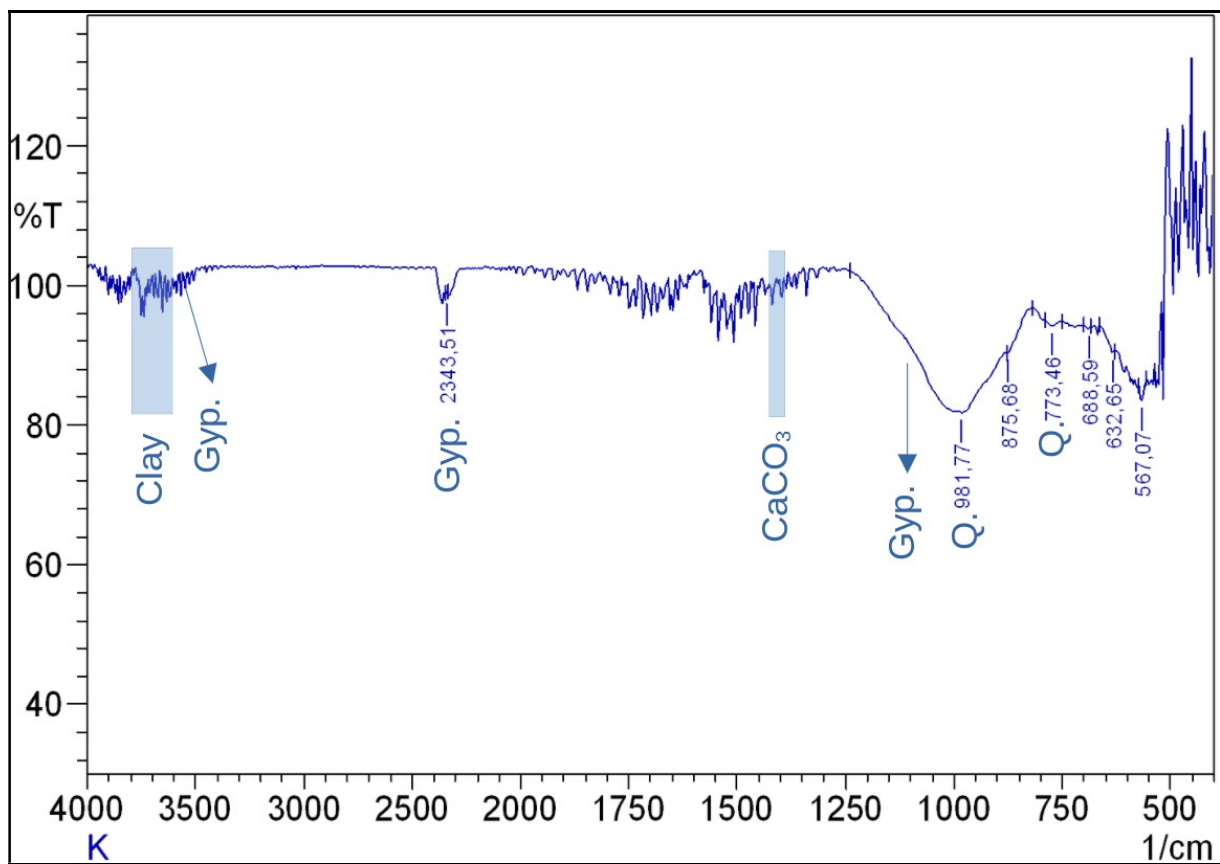
d- North sample

stress vibrations and Si-O bending vibrations. Given these differences, it is possible to say that Si-O interactions in the crystal structure are in different positions. It also shows that the crystal structures are different. The range of 3800-3600 cm^{-1} corresponds to clay minerals, there are small decrease of transmittance in this range at all samples. The fact that the O-H stress bands which occur due to the presence of clay minerals in the range of 3800-3600 cm^{-1} , were not strongly observed in the FT-IR spectra of the bricks used on the west and north facades, indicating that the clays in the raw materials of these bricks were completely dehydrated during the firing process [14]. There are also slight increase of transmittance around 1500-1450 cm^{-1} which is probably due to carbonate ions indicating the presence of calcite minerals. Natural gypsum show strong decrease of transmittance at 3540 cm^{-1} , 3400 cm^{-1} , 3240 cm^{-1} , 2914 cm^{-1} , 2846 cm^{-1} , 2326 cm^{-1} , 2210 cm^{-1} , 2091 cm^{-1} , 1682 cm^{-1} , 1620 cm^{-1} , 1458 cm^{-1} , 1143 cm^{-1} , 1115 cm^{-1} , 669 cm^{-1} , 600 cm^{-1} and 449 cm^{-1} wavenumbers [15]. Especially at wavenumbers of 3540 cm^{-1} , 3400 cm^{-1} , 1620 cm^{-1} , 1143 cm^{-1} , 1115 cm^{-1} , 669 cm^{-1} and 600 cm^{-1} there are high intensity peaks. Possible gypsum peaks are also shown in Figure 5.

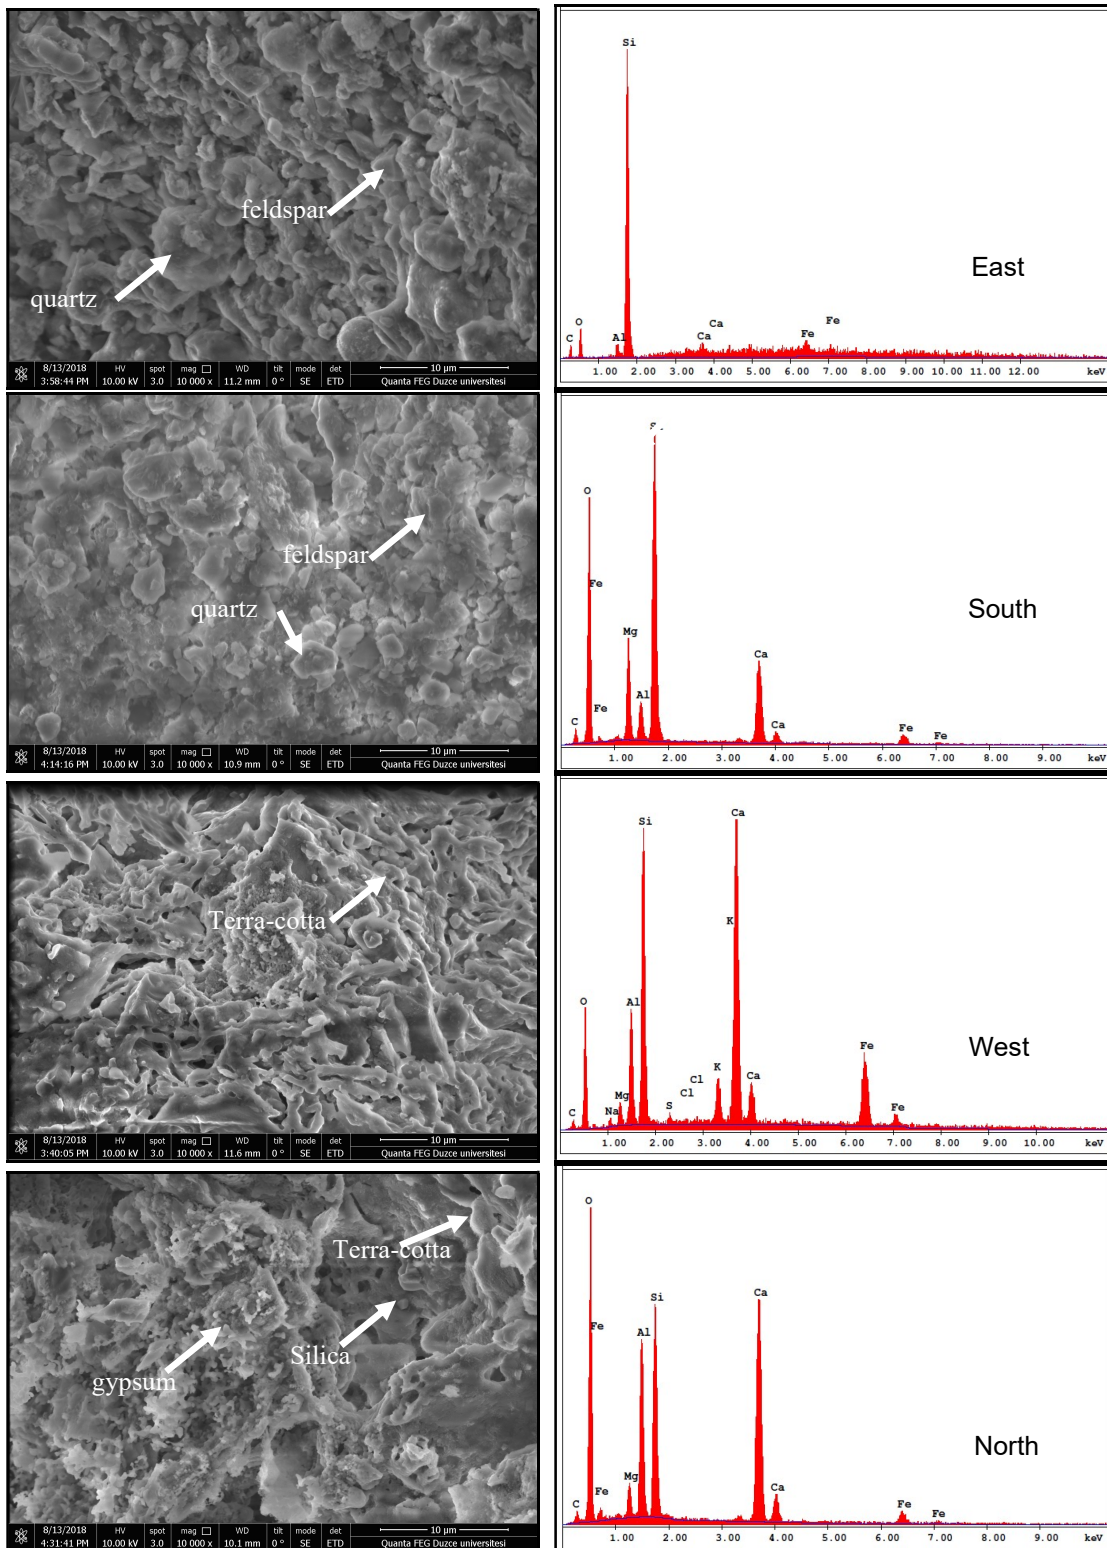
Fig. 5 - SEM and EDS analysis results of the samples

When the results of SEM and EDS analysis are examined, it is seen that the particles forming the structures of the samples taken from the eastern and southern facades are almost homogeneously distributed and they are mostly Si-containing structures. The baked clay products used in the western and northern facades appear to have a structure formed by Si, Al and Ca and its compounds. It was observed that the particles were in a tight form, there was no excess space and very large particles. Particularly, it was observed that the samples taken from the western and northern facades show a heterogeneous structure in the SEM photographs and there are regional gaps in the inner structure.

It was observed that the inner structures of the samples in the eastern and southern facades were generally homogeneous, the particles were in a tight form, there were no excessive gaps but the inner structures of the samples taken from the western and northern facades were heterogeneous and the inner structure had regional gaps.

In the study, the characterization of the materials used in the construction of Ankara Castle is carried out and important findings are obtained to shed light on the selection of materials that can be used in restoration works. Renovation works of Ankara Castle should be evaluated by considering these data and appropriate materials should be used.
