MONITORIZAREA COMPORTĂRII MATERIALELOR DE RESTAURARE APPLICATE EXPERIMENTAL ÎN BISERICA RUPESTRĂ “CORBII DE PIATRĂ” MONITORING OF THE BEHAVIOR OF RESTORATION MATERIALS EXPERIMENTALLY APPLIED IN RUPESTRAL CHURCH CORBII DE PIATRĂ

ILEANA MOHANU^{1*}, ROXANA FECHET¹, IONELA PETRE¹, NICOLETA CÎRSTEA¹, DAN MOHANU²,
IOANA GOMOIU³

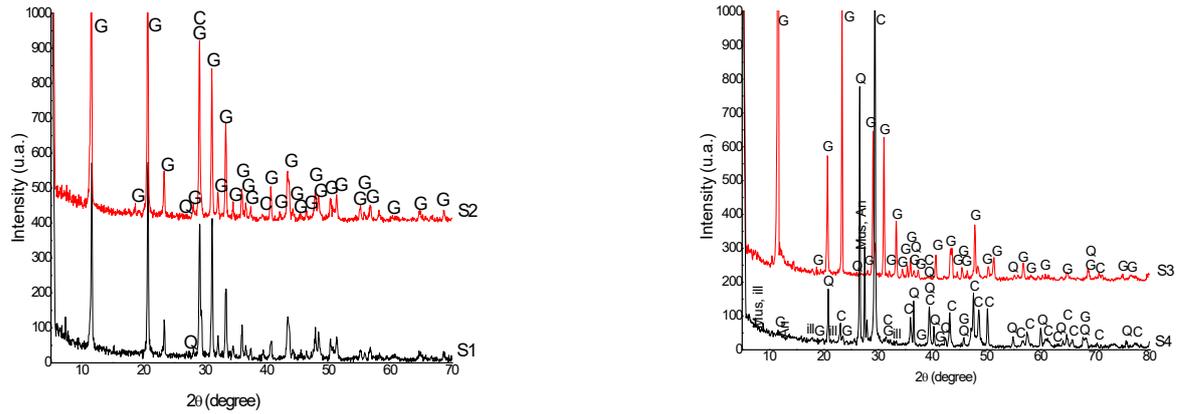
The mineralogical analysis of the S1 and S2 samples taken from the areas with efflorescences from the upper part of the iconostasis, highlighted the almost exclusive presence of gypsum, as a product of degradation of the mural support (Fig. 1a). In the case of these samples, in addition to the infiltration waters, the gypsum can also come from the brick from which the iconostasis is built [9]. Traces of calcite and quartz come from the support of the mural. Samples S3 and S4 taken from the altar, from the arches from the north, the areas with crusts, contain gypsum, but in different proportions (Fig. 1b). In S3 sample, gypsum is predominant, calcite and quartz being in traces. Sample S4 taken from the median arch contains mainly the minerals of the fresco: mainly calcite and quartz, together with anorthite, illite, muscovite; the gypsum is in traces. Sample S5 taken from the vault of northern anaphora contains the minerals of the fresco (calcite, quartz, muscovite and anorthite); no gypsum was identified in this sample (Fig. 2a). In contrast, sample S6 taken from the crusts on the table of the northern anaphora in the altar contains mainly gypsum and traces of calcite and quartz (Fig. 2b). The variations observed in the gypsum content

Fig. 1 - X-ray diagrams of samples S1 and S2 - veils of efflorescences from the upper northern part of the iconostasis (a) and of samples S3 and S4 - crusts on the northern arches of the altar (b): G – gypsum, C – calcite; Q – quartz; ill – illite; An – anorthite; Mus – muscovite / *Difractogramele probelor S1 și S2 - voaluri de eflorescențe în partea nordică superioară a iconostasului (a), și ale probelor S3 și S4 - cruste pe arcele nordice ale altarului (b): G – gips, C – calcit, ill – ilit, An – anorit, Mus – muscovite.*

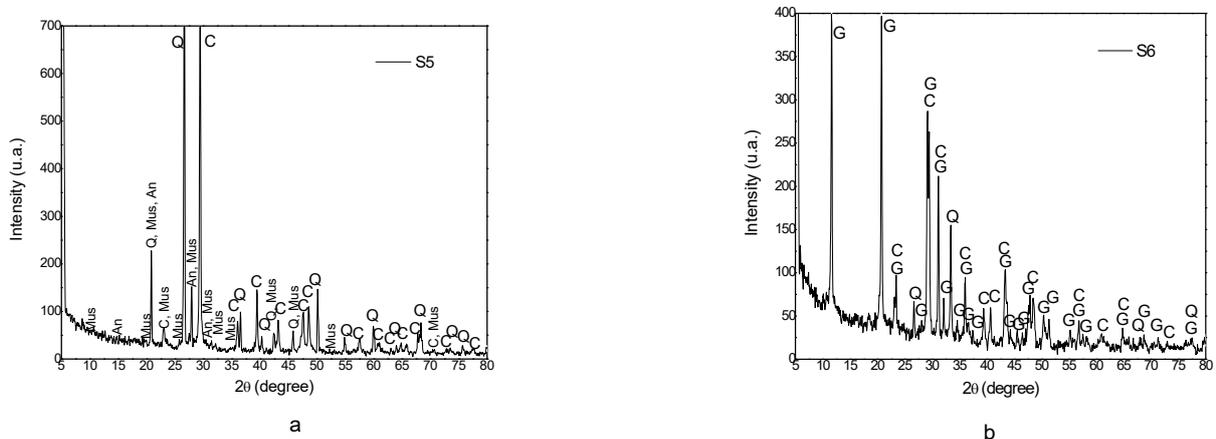
Fig. 2.- X-ray diagrams of the S5 sample from the altar, the vault of the northern anaphora, crusts (a) and the S6 sample from the altar, the mass of the northern anaphora, crusts (b): Q – quartz; C – calcite; An – anorthite; Mus – muscovite; G – gypsum / *Difractogramele probei S5 din altar, bolta nordică a proscomidiei, cruste (a) și probei S6 din altar, masa proscomidiei nordice, cruste (b): Q – cuarț, C – calcit, An – anorit, Mus – muscovit, G – gips.*

of samples S3-S6 are due to the existing crack system in the walls that allows the entry of infiltration water differently [7].

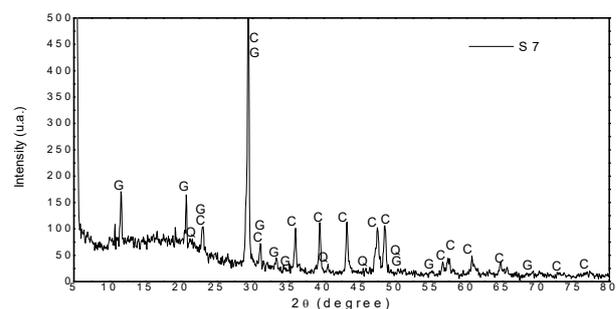
The X-ray diffractogram made on the S7 sample, taken from the crust on the decontaminated fresco and from which the salts were superficially removed, from the nave, the northern wall, shows the predominant presence of gypsum from infiltration waters, as well as traces of calcite and quartz from the support of the mural (Fig. 3).

Fig. 3 -X-ray diagram of the S7 sample from the nave, decontaminated area, crusts: – gypsum; Q – quartz; C – calcite / *Difractograma probei S7 din naos, zona decontaminată, cruste: G – gips, Q – cuarț, C – calcit.*

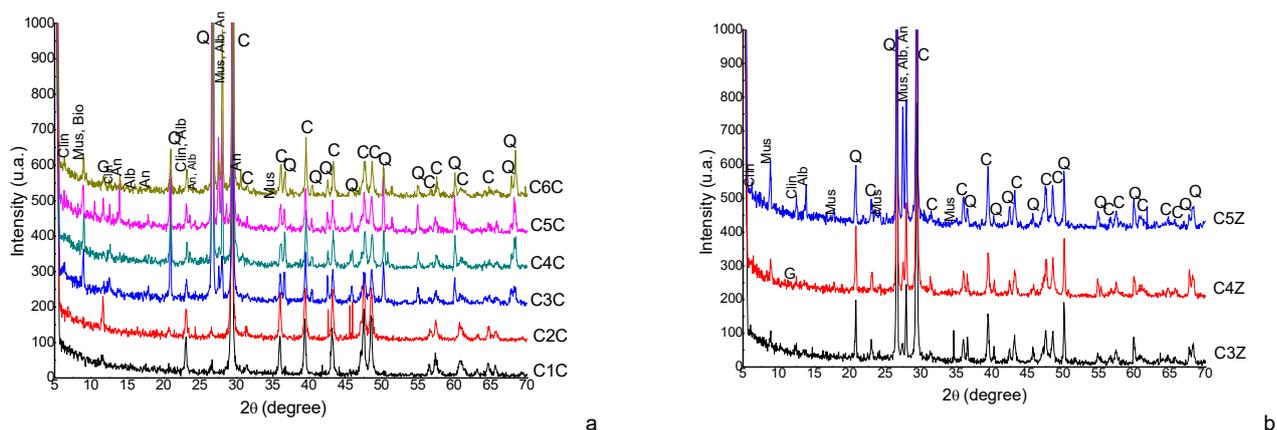
In the case of samples taken from restoration mortars applied to the iconostasis, the intensity of the gypsum-specific lines in the X-ray diffractograms is lower than in the case of samples taken from the original fresco. This suggests that gypsum is found in smaller quantities in restoration mortars (Fig. 4a). In the restoration mortar samples on the wall, the gypsum was identified only in the

C4Z sample, and only in traces. The other minerals identified are those of restoration mortars: calcite, quartz, anorthite, albite, muscovite, clinocllore (Fig. 4b).

Fig. 4 - Diffractograms of samples taken from restoration mortars applied to the iconostasis (a) and to the northern wall of the altar (b): C – calcite; Q – quartz; G – gypsum; An – anorthite; Alb – albite; Mus – muscovite; Clin – clinochlore / *Diffractogramele probelor prelevate din mortarele de restaurare aplicate pe iconostas (a) și pe peretele nordic al altarului (b): C – calcit, Q – cuarț, G – gips, An – anortit, Alb – albit, Mus – muscovit, Clin - clinoclor*

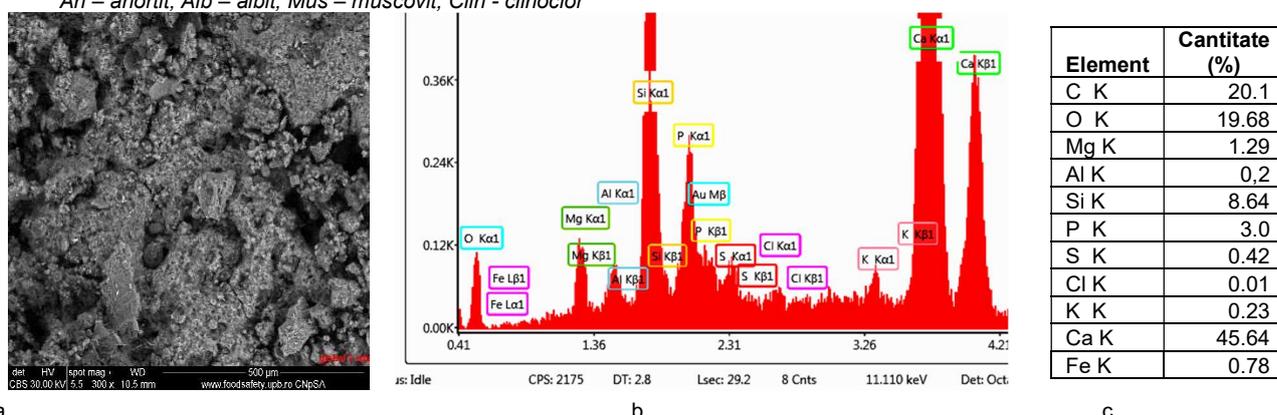
Fig. 5 - Sample taken from the altar, near the area of experimental application of mortars: SEM image (a); elemental analysis spectrum (b) and quantitative elemental analysis (c) / *Probă prelevată din altar, aproape de zona mortarelor aplicate experimental: imagine SEM (a); spectrul de analiză elementală (b) și analiza elementală cantitativă (c).*

The sample ST consists mainly of the calcium and silicon elements, as well as magnesium, aluminum, potassium, iron which are found in the minerals of the original fresco and the sandstone rock. The sulfur element was also identified in small quantities, coming from the infiltration waters with gypsum content (Fig. 5). The sample also contains the element phosphorus, which may be generated by biological contamination, the sample being covered by numerous branched hyphae (Fig. 6). Microbial colonization was very low, being visible only under electron microscope.

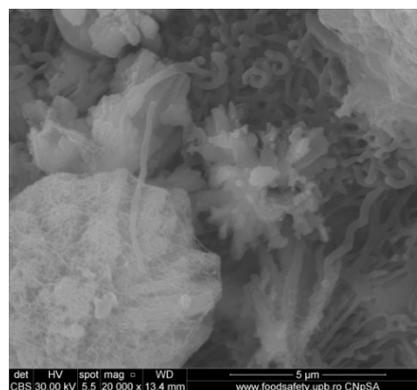
Fig. 6 - SEM image of the ST sample covered by branched hyphae / *Imagine SEM a probei ST acoperită cu hife ramificate.*

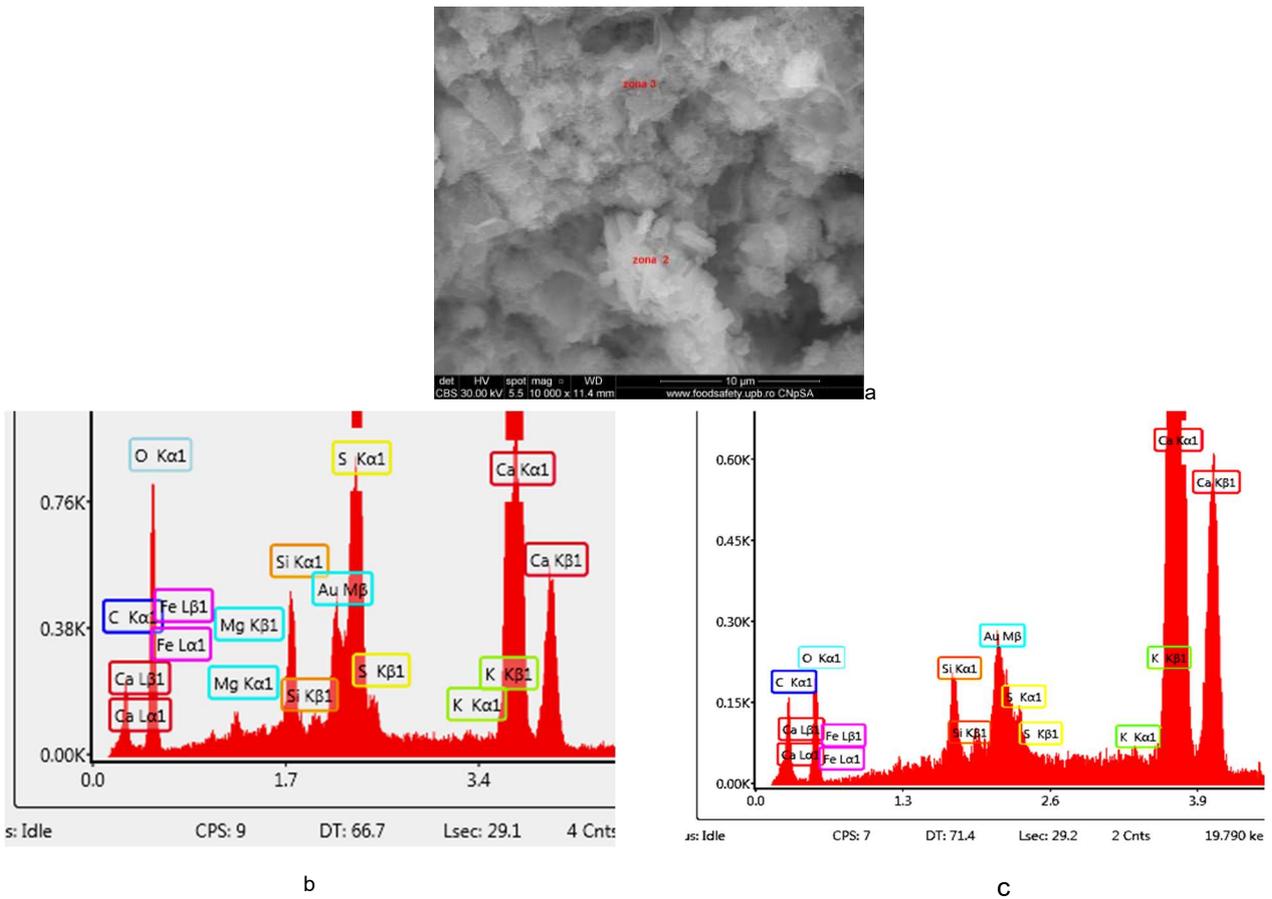
The electron microscopy analysis of the S7 sample taken from the fresco revealed the presence of the sulfur element in both points analyzed with EDX (Fig. 7), which may be an indication that the sample taken from the crust on the surface of the fresco contains gypsum. Zone 2 has a lamellar morphology (Fig. 7 a) and is richer in sulfur

(Fig. 7 b) than zone 3 in which it is in traces (Fig. 7 c). The presence of calcium is due to the binder (lime), and the silicon, iron, magnesium, potassium elements belong to the mortar aggregate. This result correlates well with the diffractometric analysis, which highlighted the existence of gypsum, in addition to calcium carbonate from binder, quartz and other minerals of the aggregate. Although the surface of the fresco was cleaned in 2009 of salts, the fact that the water containing sulfate and calcium ions continues to infiltrate,

Fig. 7 -S7 sample taken from the edge of the fresco decontaminated and cleaned of salts, from the nave, the western niche of the northern wall: SEM image (a); elemental analysis spectra of areas 2 (b) and 3 (c) / Proba S7 prelevată de pe muchia frescei decontaminată și curățată de săruri, din naos, nișa vestică a peretelui nordic: imagine SEM (a); spectrele de analiză elementală a zonelor 2 (b) și 3 (c).

from the Cascadei brook, the reappearance of gypsum crusts took place. No traces of biological contamination were observed on this sample.

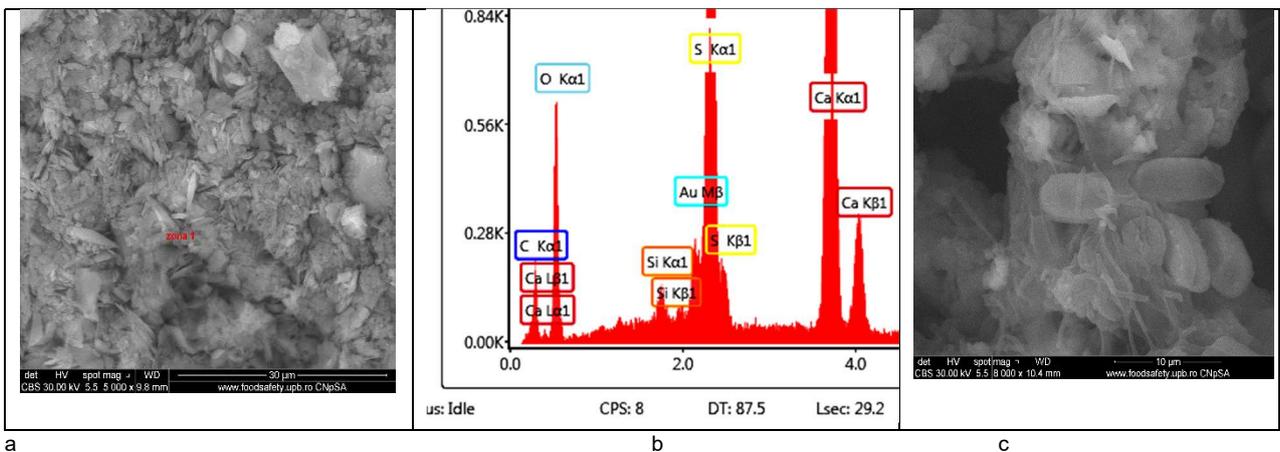
In the electron microscopy image of the S8 sample, taken from the gap (Fig. 8 a), it is observed that the surface of the sample is covered with

crystals in the form of lamellae. The elemental analysis performed on a group of such crystals highlighted mainly the elements sulfur and calcium (Fig. 8 b), which indicates the presence of gypsum in the sample. The surface of the sample is heavily contaminated biologically. In Figure 8 c actinomycetes and algae are observed.

Fig. 8 - S8 sample taken from the nave, the western niche of the northern wall, the gap in the surface cleaned of salts and decontaminated: SEM image showing gypsum crystals (a); elemental analysis spectrum of zone 1 (b) and actinomycetes (c) / Proba S8 prelevată din lacuna de pe suprafața decontaminată și curățată de săruri, din naos, nișa vestică a peretelui nordic: imagine SEM în care se observă cristalele de gips (a); spectrul de analiză elementală al zonei 1 (b) și actinomicete (c).

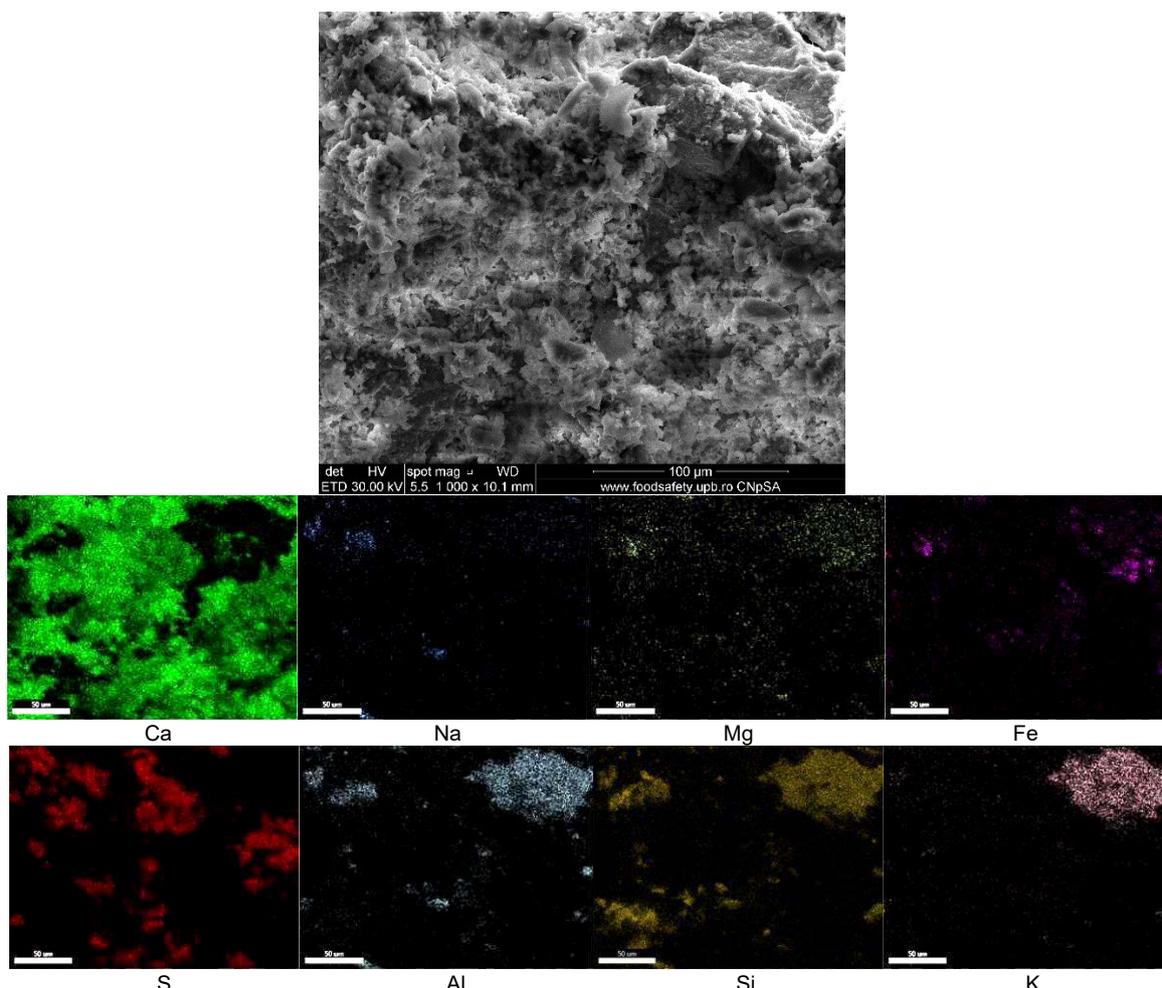
In all mortars experimentally applied on the iconostasis, the EDX spectra highlighted the sulfur element. It was observed on the entire surface of the investigated samples, being in large proportions, according to the quantitative elemental analysis (5.18 ... 24.78%). The presence of calcium beside sulfur, as well as the scaly or lamellar morphology suggests that there is gypsum in those areas (Fig. 9).

Fig. 9. - SEM image of the C3C sample and positioning of the elements contained in the sample / *Imagine SEM a probei C3C și poziționarea elementelor conținute.*

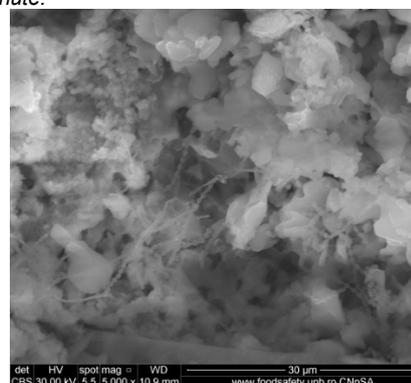
The samples are contaminated with actinomycetes, which are not visible under optical microscope but frequently visible in electron microscopic images (Fig. 10). Carotenoid pigment-producing bacteria have been identified in some areas with efflorescence under an optical microscope.

Fig.10 - SEM image of the C4C sample: actinomycetes included in the biofilm / *Imagine SEM a probei C4C: actinomicete incluse in biofilm.*

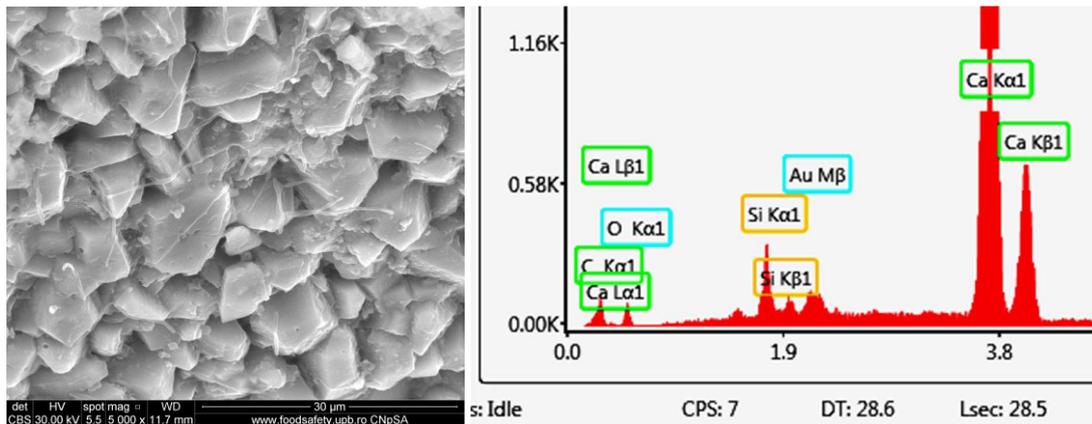
infiltration moisture, a slight solubilization of the calcium carbonate in the mortars took place, which, in optimal conditions of temperature and humidity and in the presence of carbon dioxide in the air, recrystallized on the surface of the mortars [10].

On the surface of the analyzed samples there is a fine crust in which the calcium element is predominant (Fig. 11). Possibly, due to the

Fig. 11 - SEM image of calcite crystals on the C5Z sample surface and related elemental spectrum / Imagine SEM a cristalelor de calcit de pe suprafața probei C5Z și spectrul elemental aferent.

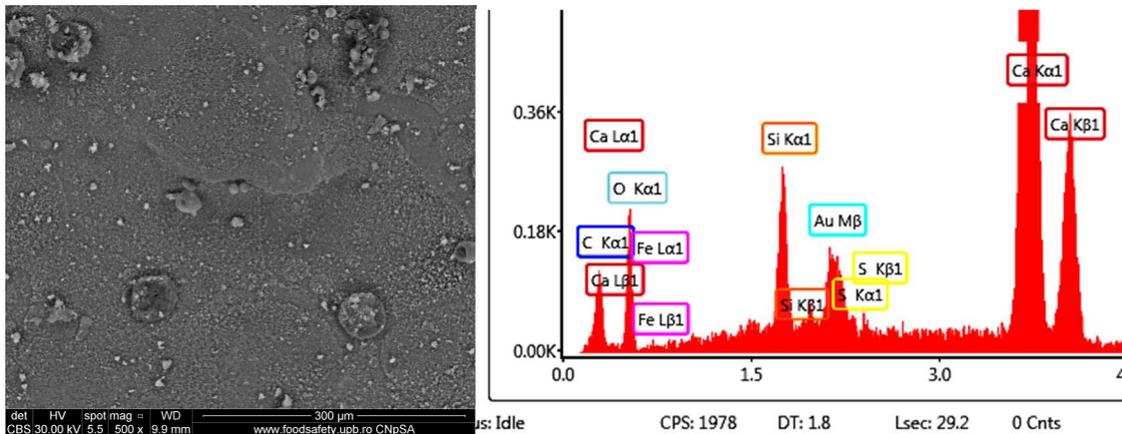
Sulfur was highlighted only on the crust surface of the C3Z sample, in proportion of 1.61% (Fig. 12).

Fig. 12. SEM image of the C3Z sample and the elemental spectrum / Imagine SEM a probei C3Z și spectrul elemental.

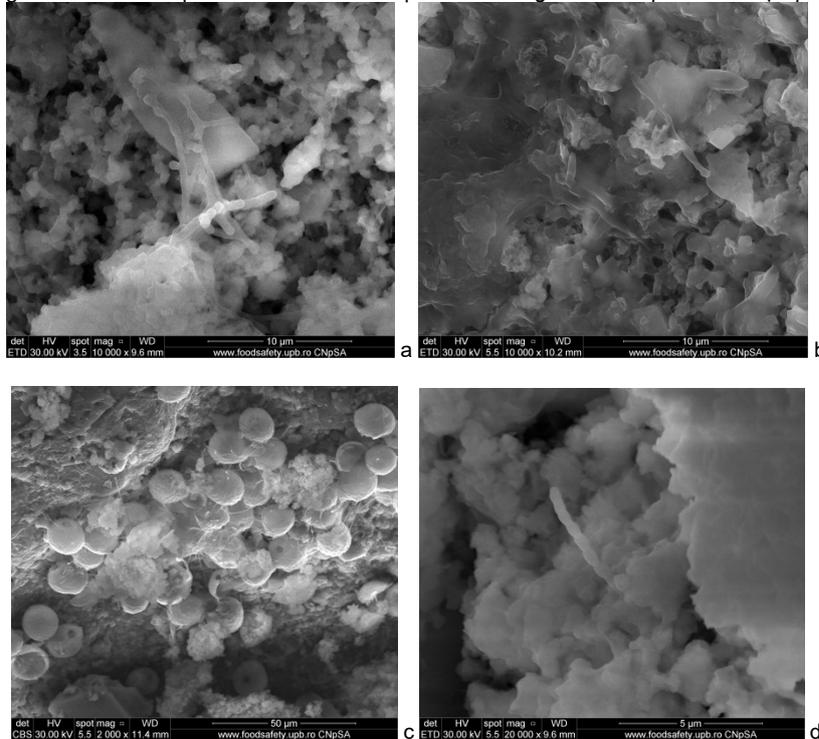
Fig. 13.- Biological contamination of restoration mortars applied on the Nordic wall of the altar: a - non-sporulated mycelium formed by weakly branched hyphae; b - biofilm consisting of single-celled algae to which hyphae adhere; c - cocci; d - bacilli arranged in chains / Contaminare biologică a mortarelor de restaurare aplicate pe peretele nordic al altarului: a - miceliu nesporulat format de hife slab ramificate; b - biofilm format din alge unicelulare la care aderă hifele; c - cocci; d - bacili dispuși în lanțuri.

Has been put in evidence bacilli arranged in chains, cocci, non-sporulated mycelium formed by weakly branched hyphae, biofilm formed by green algae adhering to hyphae (Fig 13).
