REZISTENȚA UNOR NOI MORTARE LA BIODETERIORARE RESITANCE OF NEW MORTARS TO BIODETERIORATION

IOANA GOMOIU^{1*}, MĂDĂLIN ENACHE¹, DAN MOHANU², ILEANA MOHANU³, IONELA PETRE³
ROXANA COJOC¹

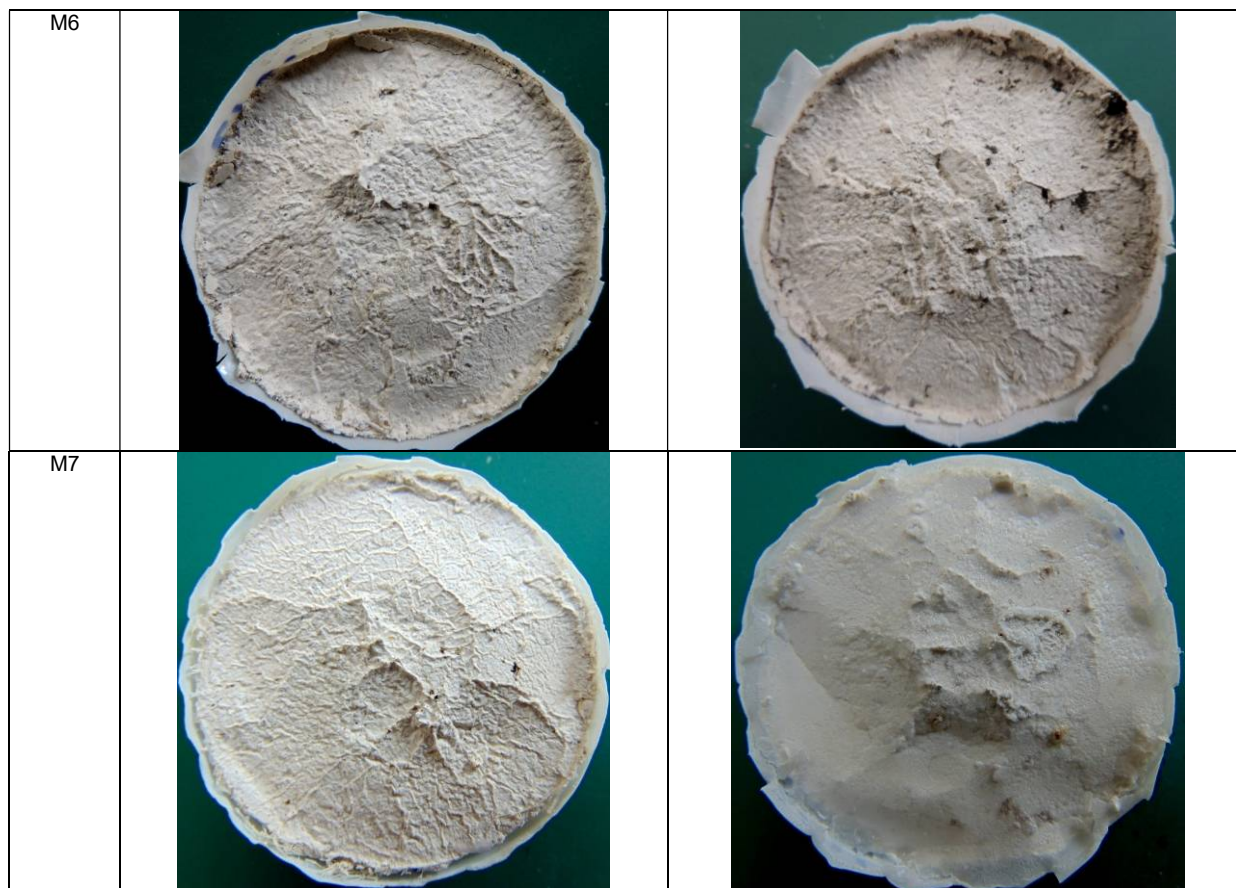
Table 6

Visual examination of fungal growth on mortar and mortar+glucose (9 months)
Examinarea vizuală a creșterii fungilor pe mortar și mortar+glucoză (9 luni)

Mortar code Codul mortarului	Fungal growth on mortar / Creșterea fungilor pe mortar	Fungal growth on mortar+glucose / Creșterea fungilor pe mortar+glucoză
M4	 	 
M5

Visual examination revealed the appearance of mycelium from day 10 after inoculation on the mortar+glucose and from day 15 on the mortar without glucose. Between 30-90 days, an increased colonized surface of all samples had been noticed and till 9 months, the rhythm of surface colonization decreased very much (Table 6). After 90 days of incubation, the crystallization of salts was more visible on M6 and M7 mortar. Biodeteriogens grew better on the mortars with glucose, producing significant biomass and a large surface of colonization.

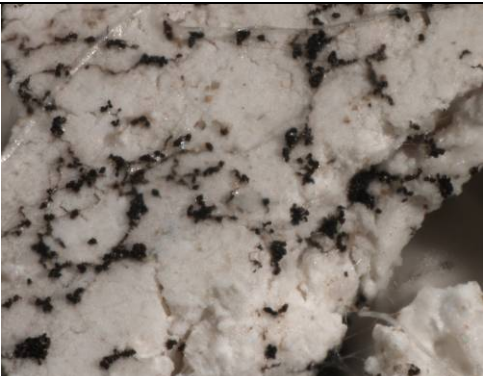
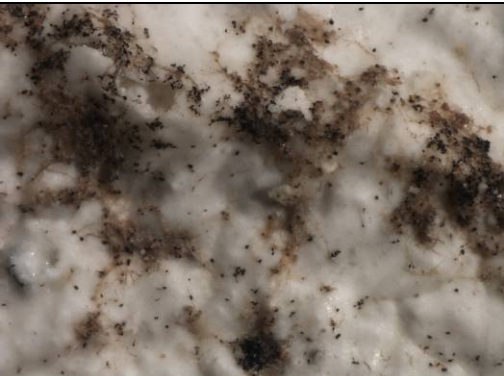
Table 7

Microscopical examination of fungal growth on mortar and mortar+glucose (9 months)
Examinarea microscopică a creșterii fungilor pe mortar și mortar+glucoză (9 luni)

Mortar code / Codul mortarului	Fungal growth on mortar / Creșterea fungilor pe mortar	Fungal growth on mortar+glucose / Creșterea fungilor pe mortar+glucoză
M4

Optical observations confirmed the presence of germination spores, branched hyphae, white non sporulated mycelium, sporulated mycelium belonging to all inoculated species (table 7). The addition of glucose stimulated spores germination. This process was identified by microscopical examination starting with the third day after inoculation. Crystallization of salts took place on the surface of all types of mortar. Microscopical observations confirmed an extensive crystallization of salts on M5 and M7 mortars. The fact that fungi are able to grow also on the mortars

covered by salts reveals that all inoculated strains are resistant to high concentration of salts. In case of M7 mortar+glucose, it was noticed both by visual and microscopical examination that the surface was completely covered by a crust of salts developed after colonization. This process may have occurred *in situ* and thus, only through visual examination, the sporulated mycelium located beneath the crust could not be identified. Only when the crust will fall or be removed, the hyphae and spores will be detached and will contaminate surrounding areas.
