# COMPORTAREA GRINZILOR DIN BETON ARMAT SOLICITATE ÎN REGIM DINAMIC ÎN DIVERSE STADII DE DEGRADARE

## BEHAVIOUR OF REINFORCED CONCRETE BEAMS SUBJECTED TO DYNAMIC LOADING IN VARIOUS STAGES OF DEGRADATION

CONSTANTIN GAVRILOAIA, NICOLAE ȚĂRANU\*, RALUCA ONOFREI, MIHAI BUDESCU, PETRU MIHAI, IOANA-SORINA ENȚUC

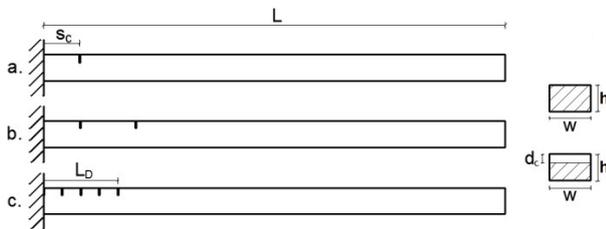
Fig. 1 - Damaged beam model / Model grindă degradată:

- a. with a single crack / cu o singură fisură; b. with multiple independent cracks / cu fisuri multiple independente; c. with multiple cracks which interact / cu fisuri multiple ce interacționează

When there is a small crack, Figure 1a, the degraded model is represented by two parameters: position of crack and damage level.

The degradations corresponding to the multiple cracks can be analyzed using the model of those with only one crack but considering a hinge with rotation stiffness for each crack. If the multiple cracks are independent, Figure 1b, they will be localized at a bigger distance than the conventional length of the affected area. When the cracks are

multiple and interact between them, Figure 1c, the region in which they appear will have a lower stiffness. The last case is typical for the reinforced concrete elements.

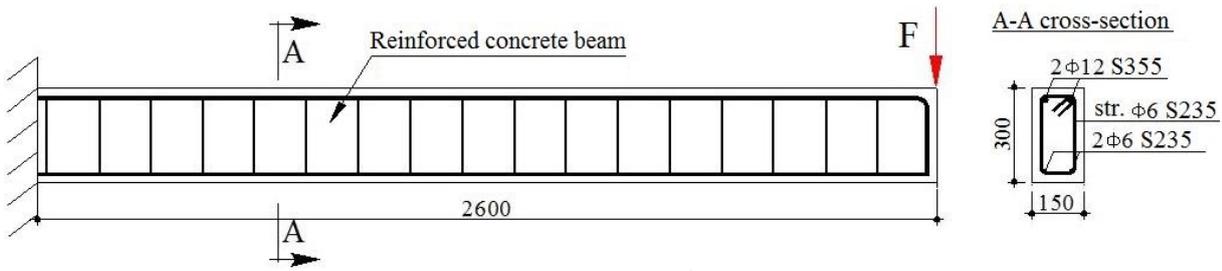
Fig. 2 - The reinforced concrete element composition, beam G1/G2 / Alcătuirea elementului din beton armat, grinda G1/G2.

- length  $L = 2.60$  m;
- transverse cross-section  $0.15 \times 0.30$  m;
- concrete cover  $a = 0.025$  m;
- concrete class C12/15;
- reinforcement at the inferior part: two longitudinal plain bars made of steel S235 [10] with the nominal diameter of 6 mm;
- reinforcement at the superior part:
  - beams G1 and G2: two longitudinal ribbed bars made of steel S355 [10] with the nominal diameter of 12mm, Fig. 2;
  - beams G3 and G4: three longitudinal ribbed bars made of steel S355 with the nominal diameter of 12mm;
- transverse reinforcement: stirrups made of steel S235 with the nominal diameter of 6mm, positioned at the distance of 150mm.

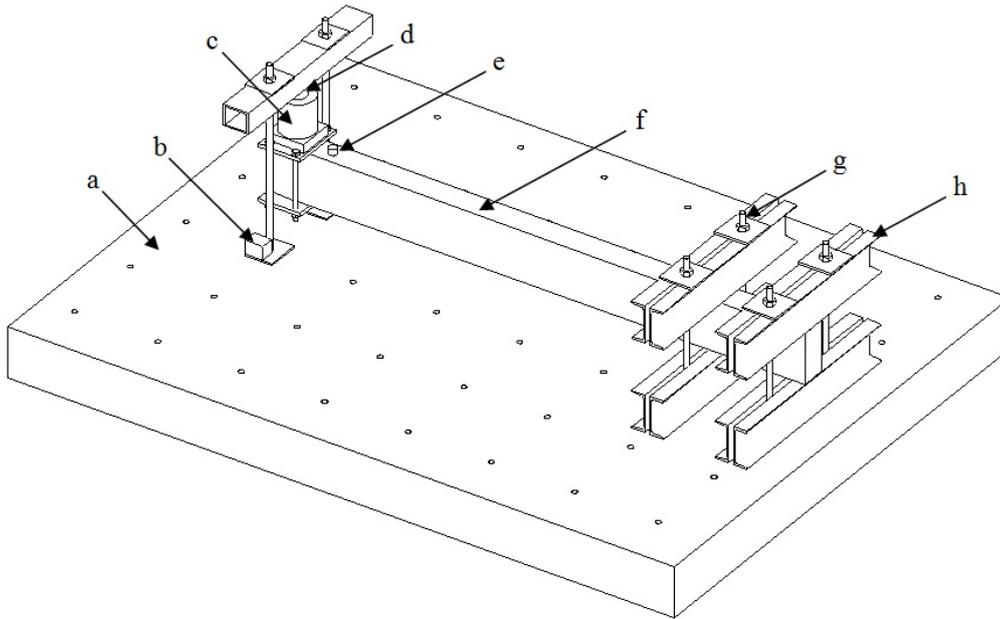
Fig. 3 - Outline of the experimental testing / Schema de ansamblu a încercării experimentale: a. concrete stand / platformă din beton; b. displacement transducer / traductor de deplasare; c. hydraulic jack / cric hidraulic; d. force cell / traductor de forță; e. accelerometer / accelerometru; f. reinforced concrete beam / grindă din beton armat; g. bolts / buloane; h. steel profiles / profile metalice.

The testing stand was built so that the structural model of the reinforced concrete beams was a cantilever. A force transducer with a capacity of 50 kN and a displacement transducer with a wire and an accelerometer, has been utilized for the data acquisition system,

positioned as shown in Figure 3. During the test, between the beam and the loading transducer metallic plates have been positioned so the loading on the free end of the element was uniformly applied.

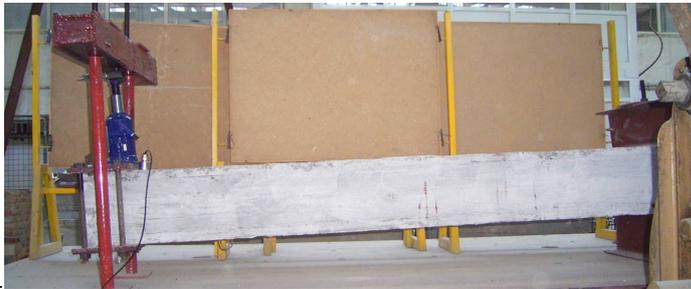
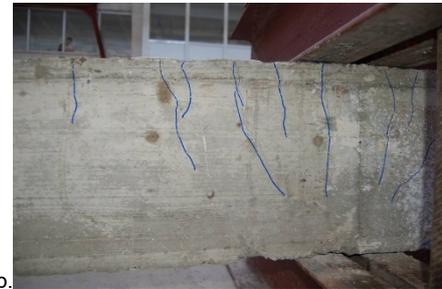
Fig. 4 - a. Beam G1 loaded until failure / Grinda G1 solicitată până la cedare; b. Crack pattern of G1 beam / Ansamblu de fisuri în grinda G1.

The beams have been subjected to bending by applying a static concentrated increasing load in the free end until failure, Figure 4.

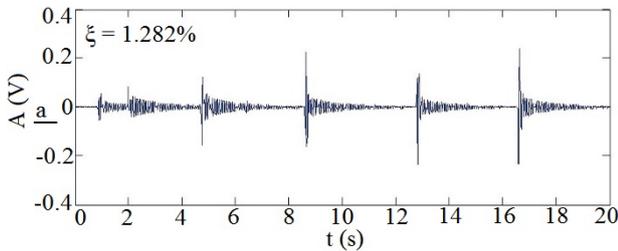
Fig. 5 - Time-domain response for the G1 beam. Loading step: 0 kN / Răspuns în domeniul de timp pentru grinda G1. Treapta de încărcare: 0 kN

The action of the impulse given by the rubber hammer can be observed in Figure 5. On the graphic display this is represented by a maximum of the acceleration, which has a damped decrease in approximately 15 seconds.

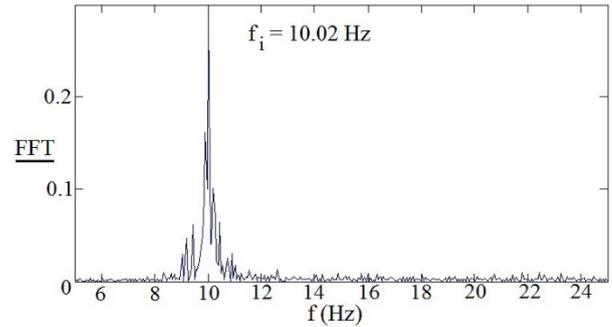
Fig. 6 - FFT analysis for the G1 beam. Loading step: 0 kN / Analiza FFT pentru grinda G1. Treapta de încărcare: 0 kN.

A frequency of 12.35 Hz was obtained for the first loading step, using the Fast Fourier Transform (FFT) analysis, Figure 6. The frequency determined analytically for an undegraded state was 19.98 Hz. It can be observed that the first cracks have a very high influence on the element stiffness and on the vibration frequency.

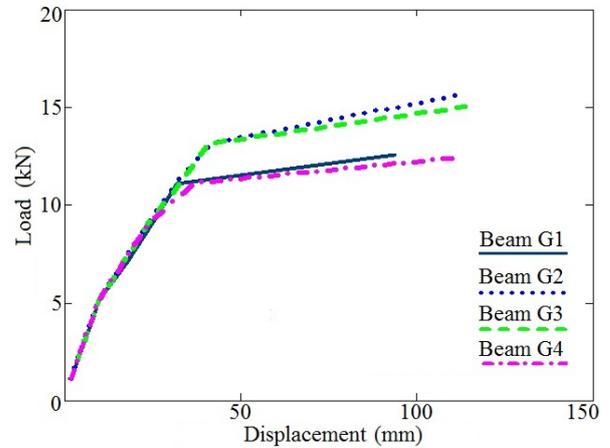
Fig. 7 - Load-displacement graph for the beams G1 - G4 / *Grafic încărcare-deplasare pentru grinzile G1 - G4.*

By analyzing the load-displacement curves shown in Figure 7, in the first loading steps it can be noticed a higher flexural stiffness that decreases gradually, until the reinforcement reaches yielding, and at the end has a sudden drop until failure. The beginning of the reinforcement yielding can be easily distinguished on the graphs.

The shape of the load-displacement curve in Figure 13b is similar to the one displayed in Figure 7 (for the G1 and G2 beams). The finite element analysis has accurately estimated the structural

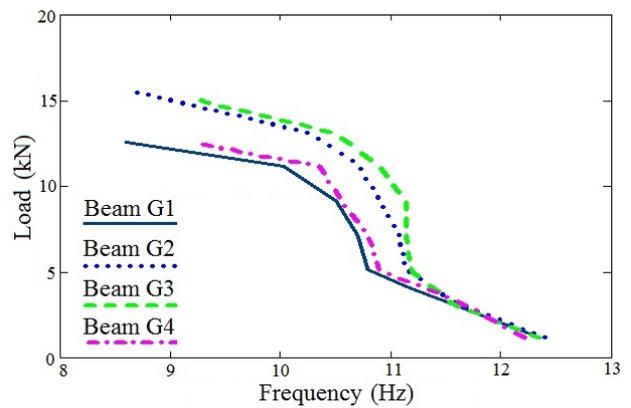
Fig. 8 - Load-frequency graph for the beams G1 - G4 / *Grafic încărcare-frecvență pentru grinzile G1 - G4.*

In Figure 8 the variation of the element frequency with respect to the loading step, which causes degradations in the element, can be observed. In the first loading steps, up to 6 kN, the frequency has an almost linear variation. In this stage, the concrete in the tensed area cracks but it still has a contribution on the flexural stiffness of the element. Between the loading step of 6 kN and up to the yielding of the reinforcement, the concrete in the tensed area has no more influence,

the load being taken only by the reinforcement. In this region, the frequency has a nonlinear decrease with respect to the loading. After the yielding of the reinforcement, the relation between frequency and loading step is still linear but it has a diminished slope.

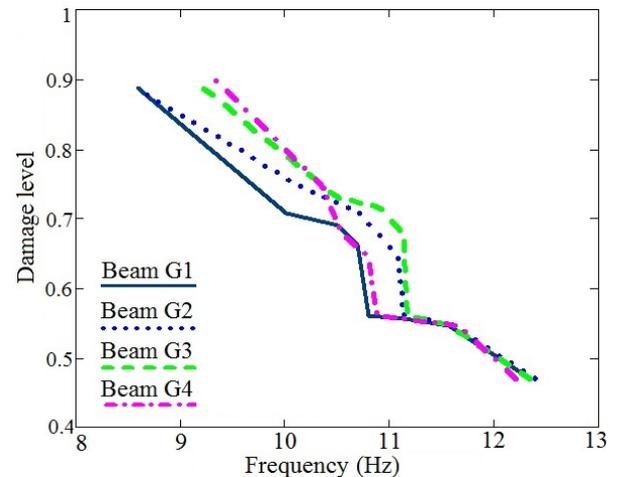
Fig. 9 - Damage level-frequency graph for the beams G1 - G4 / *Grafic grad de degradare-frecvență pentru grinzile G1 - G4.*

From the analysis of the experimentally obtained damage level - frequency graph of the reinforced concrete elements, presented in Figure 9, it can be noticed that at a more reduced damage level, up to approximately 0.55, the frequency has a linear variation with the damage level with a diminished slope. This aspect underlines the fact that for a reduced damage level the change in frequency is significant. At a damage level between 0.55 and 0.7 the frequency is maintained almost constant. A damage level of approximately 0.7 corresponds to the beginning of the reinforcement yielding. At a damage level of over 0.7 the frequency has a linear behavior with respect to the damage level but with a lower slope (frequency is slightly modified with respect to the damage level).

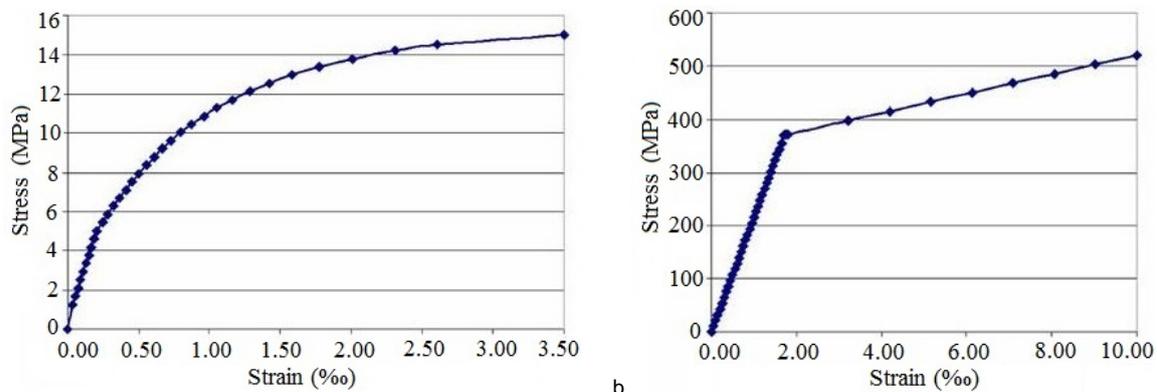
Fig. 10 - Characteristic curves of the materials for numerical modeling / *Curbele caracteristice ale materialelor pentru modelare numerică*: a. characteristic curve of concrete in compression / *curba caracteristică a betonului la compresiune*; b. characteristic curve of steel in tension / *curba caracteristică a oțelului la întindere*.

The characteristic curves used in numerical modeling are obtained based on the current standards [10, 12] and are displayed in Figure 10.

The nonlinear behavior of concrete had the following mechanical characteristics: compressive strength equal to 12 MPa, the tensile strength equal to 1.6 MPa, the elastic modulus had the value of 27 GPa and the Poisson's coefficient was equal to 0.2. The reinforcement had the yielding limit of 355 MPa and 235 MPa respectively, the elastic modulus of 210 GPa and Poisson's coefficient with the value of 0.3. The introduction in the model of the uniaxial compressive curve of concrete was performed using the Multi-Linear Isotropic Hardening (MISO) option of the computation program [13].

The concrete modeling was performed using *quadrilateral* type surface elements and had a nonlinear behavior, associated with cracking in tension and crushing in compression, defined according to the curves given in Figure 10. The reinforcement was modeled with *bar* type elements with the option to take over only axial stress. In the bars modeling the discrete representation mode was used. The reinforcement was connected to the network nodes of the concrete. A perfect bonding between the two materials (concrete and steel reinforcement) was considered in the numerical modelling.

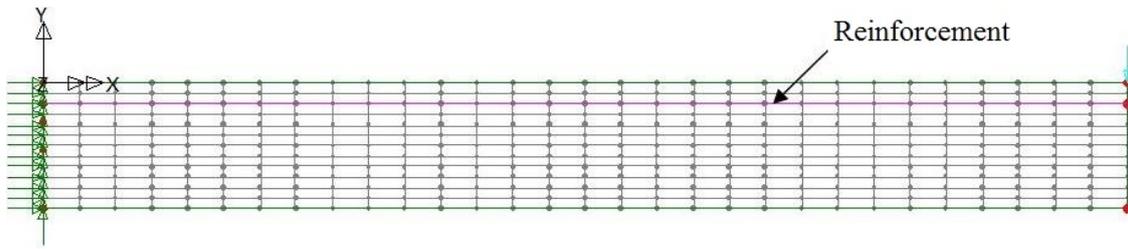
Fig. 11 - Computation model / Model de calcul

The force applied on the computation model, Figure 11, during the nonlinear analysis was divided in a series of loading steps and sub-steps. The stiffness matrix of the model was automatically adjusted based on the Newton-Raphson equilibrium iterations at the end of each loading step.

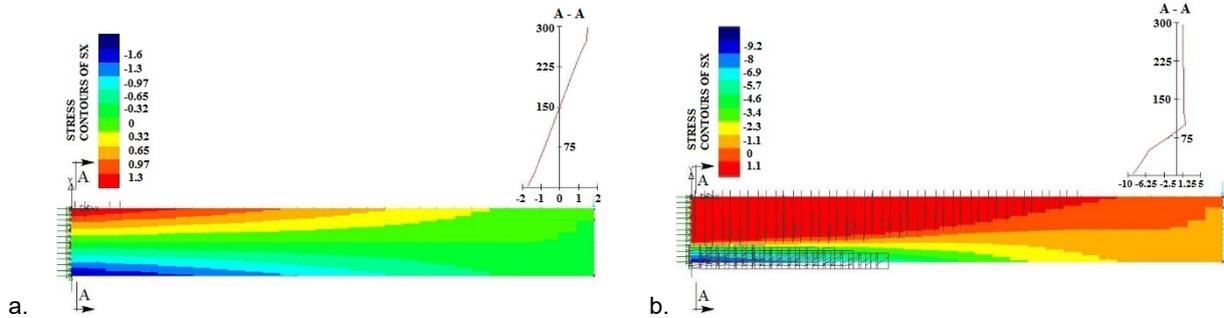
Fig. 12 - a. The normal stresses map for the first loading step / Harta de tensiuni normale pentru prima treaptă de încărcare [MPa]; b. The normal stresses map for an intermediate loading step / Harta de tensiuni normale pentru o treaptă intermediară de încărcare [MPa].

The stresses in the first loading step resulted from the self-weight of the element, Figure 12a. The transverse cross-sections from the right-hand side of the stress maps are in the fixed area. The element cracked in the tensioned area and the distribution of the normal stresses is close to a linear one.

In the intermediate loading step, Figure 12b, the concrete in the tensioned area continued to crack but cracks developed in the compressed area as well. The force for this loading step was considered equal to 6 kN.

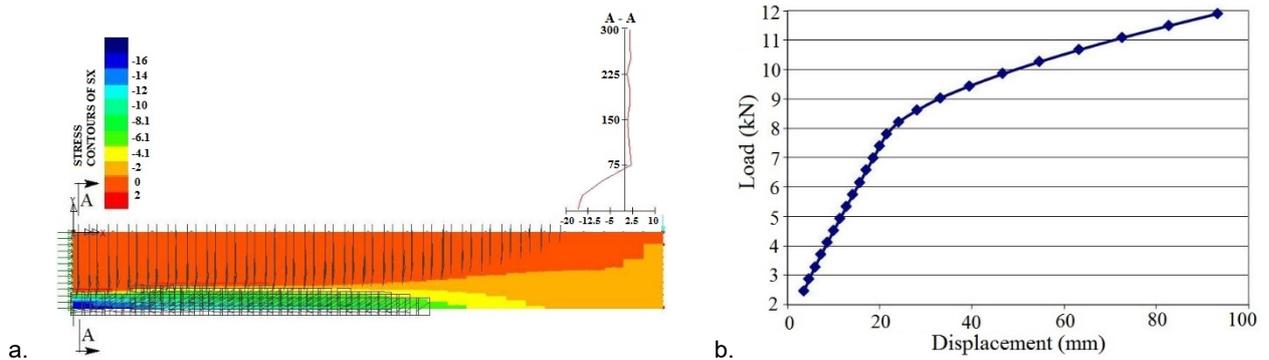
Fig. 13 - a. The normal stresses map for the last loading step / Harta de tensiuni normale pentru ultima treaptă de încărcare [MPa]; b. Load-displacement curve / Curba încărcare-deplasare.

In the last loading step, Figure 13 a, the failure of the element is produced through the breaking of the reinforcement. The concrete in the compressed area did not reach the ultimate strain. The force for this loading step was equal to 11.9kN.

The displacement in the force direction at the moment of failure was of 0.093m. The load-displacement curve of the element is presented in Figure 13b.
