COLONIZAREA MORTARELOR DE CĂTRE BACTERII ȘI FUNGI THE COLONIZATION OF MORTARS BY BACTERIA AND FUNGI

IOANA GOMOIU^{1*}, MĂDĂLIN ENACHE², ILEANA MOHANU³, ROXANA COJOC²,
SIMONA NEAGU², DAN MOHANU¹

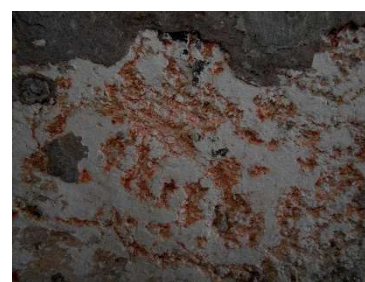
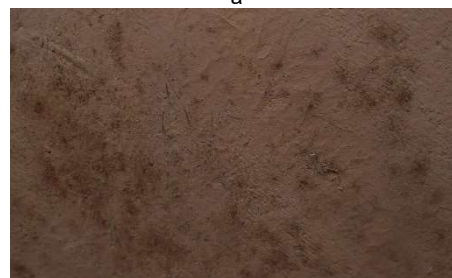
Fig.4 - Microbial pigmentation on original mortar (a) and on the infilling mortar (b). / *Pigmentația de origine microbială pe mortarul original (a) și pe mortarul de reparație (b).*

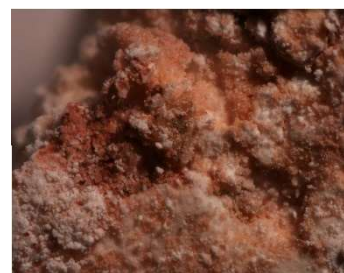
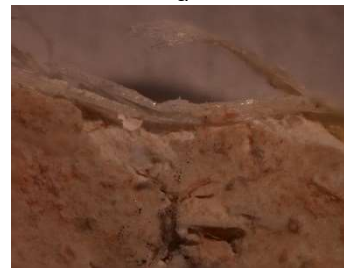
Fig.5 – Micrography of pink bacterial (a) and black fungal colonization of mortar (b). / *Colonizarea mortarului de cãtre „bacterii roz” (a) și „fungi negri” (b).*
