PRE-RESTORATION MATERIALS RESEARCH IN HISTORICAL ANKARA CASTLE

AHMET GÖKDEMİR^{1*}, TALAT YATKIN²

¹Gazi University, Technology Faculty, Civil Engineering Department, Ankara-Turkey

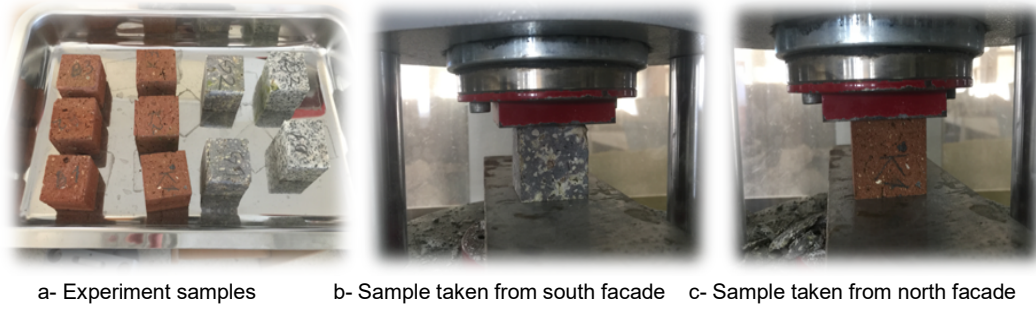
In Figure 1 there are samples taken from four different facades of historical Ankara Castle. Experiments on mechanical tests were carried out according to the principles stated in TS 699 [6]. In addition, material characteristics were tried to be revealed by Scanning Electron Microscopy analyzes SEM and EDS using scanning electron microscope (FEI Quanta FEG 250), Fourier Transform Infrared (FT-IR) spectroscopy methods as well as by examining with the optical microscope (Zeiss Imager M1m) [7-13].

Fig. 1 - Picture of the experiment samples and compressive strength experiment.
